# Stream Team Report 2009

- Broadmeadow Brook
- Hop Brook
- North East Marlborough Streams

*Study Conducted April-May 2009*

June 2009

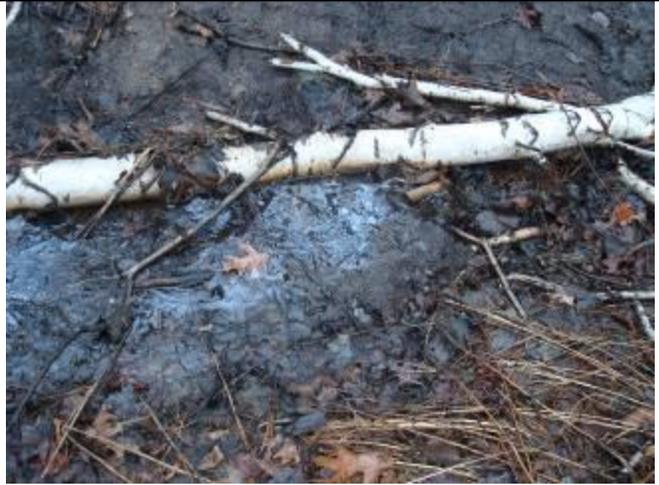
Oil spot

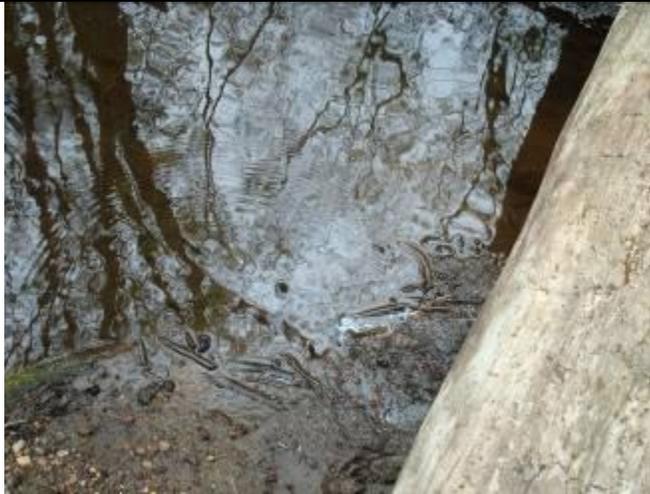
Oily sheen in water

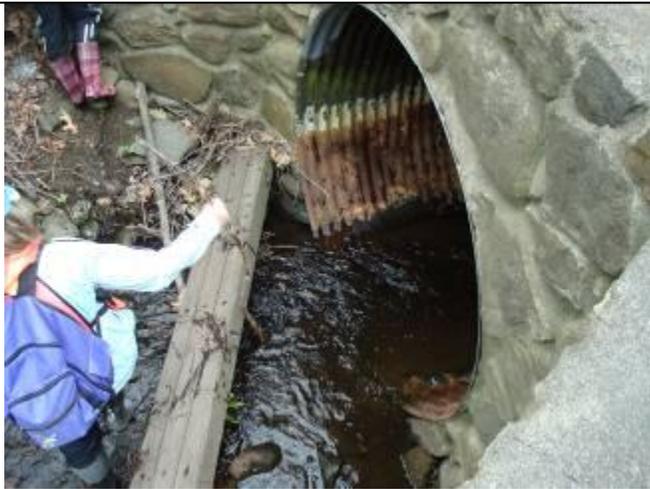
Culvert at H14 as it crosses Farm Road. Pipe is corroding on the bottom

Corroding

H-14	Culvert crossing Farm Rd. pipe is corroding at the bottom	Conservation will inform DPW	
H-15	Trash in stream tires and debris	Conservation will add to city cleanup list	
H-15	Grass clippings behind home on Helen Dr.	Conservation will inform

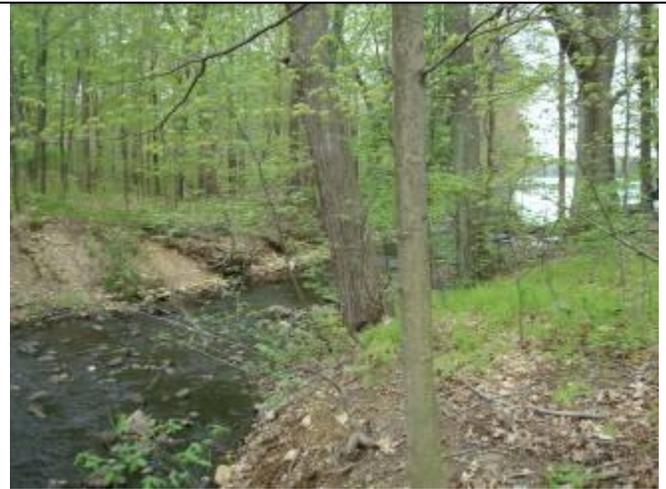
Other side of Farm Road. Oil still evident in water

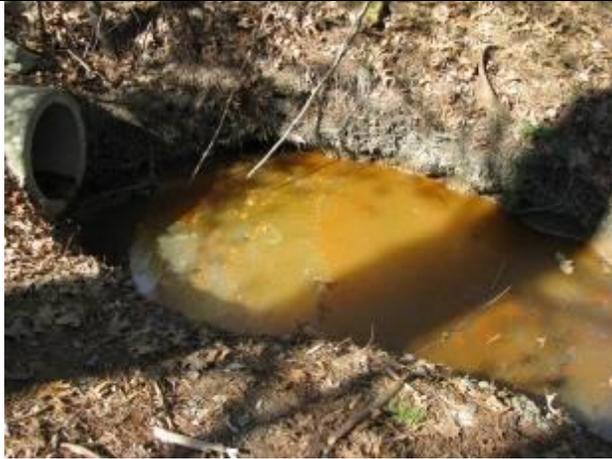
Dark rusty water comes out of a 24" diameter steel pipe behind the tall, solid white fence at the rear of the **Hess Gas Station** on **Boston Post Road**, next to **Marlborough Nissan**, in **H12**. The water is moving in a northeasterly direction. Here oil slicks are re-joining after poking.

H12 Rusty, oily water coming from 1 foot pipe

neighbors not to put clippings on stream bank-through letter	
<b>Hop Brook Steam Section</b>			
Stream section	Problem Identified	Assigned to:	status
H-12	Dark rusty water from 24" behind Hess Gas station	Conservation to check and follow up	
I-13	Orange water, pipe discharging to netting, water dirty, lots of trash	Conservation to check and follow up	This is a site of ongoing enforcement action against Waste Management Inc. and Post Rd. Auto. Enforcement and monitoring are ongoing through Conservation Commission and Engineering Dept.
H-13	Milky water and algae in pond nest to Halfway Cafe	Conservation to check and follow up	Checked June 2009 milky water and algae a result of discharge above, trash to be addressed during next clean up day with letter to restaurant owner too.
G-13	Trash at EWWTP entrance roadway to be cleaned	DPW to be notified	Was cleaned up during Clean Sweep 2009
H-15	Strong odor from water under Boston Post Rd. into Hager Pond	DPW to be notified

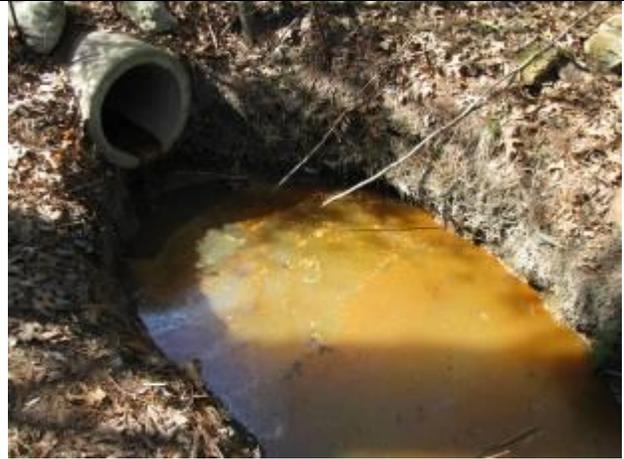
H12 Rusty, oily water coming from 1 foot pipe

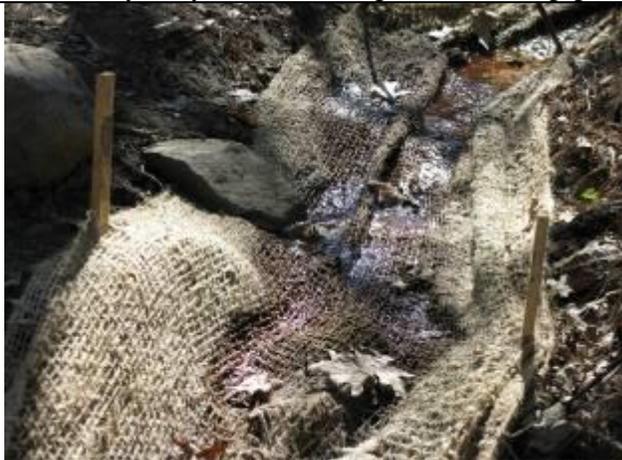
I13 Sisal netting. Trash in this area

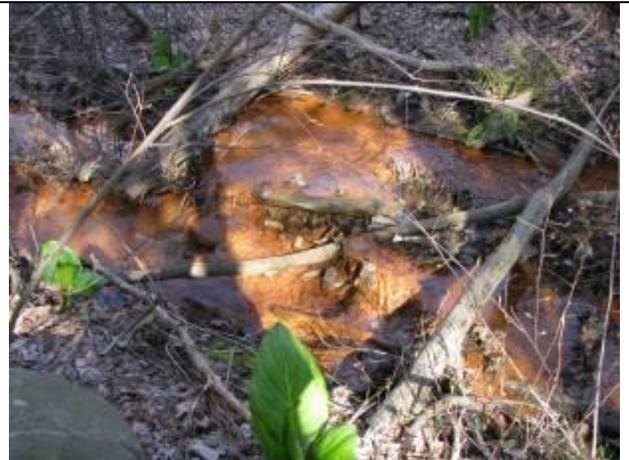
Along the driveway to **Easterly Water Pollution Control Facility** in **G13** the rapidly flowing water becomes dirty and rusty riffles (see Photos). Closer to the entrance of the **Easterly Water Pollution Control Facility** are 7 bags filled with trash, 3 tires, an air conditioner, adult entertainment advertisements, and a bleach bottle along the moderately rapidly flowing orange water which (See Photos)

G13 Rusty colored riffles

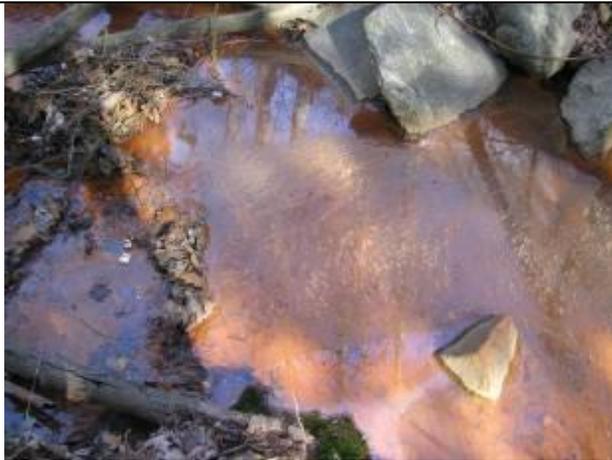
G13 Rusty colored riffles

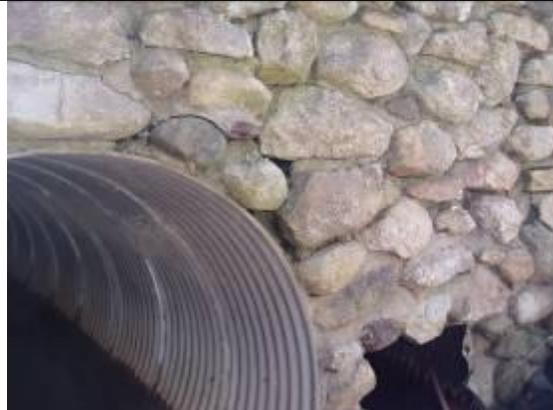
- C05 culvert near Goodale St.- rocks above pipe are cracking.
- B08 near Hemenway St. Extension- pipe is rotting out; base of culvert is broken off
- D06 culvert by Sudbury St.- rocks are shifting.
- Drainage ditch by Concord Rd./Sudbury St. intersection. When the water level drops in the summer, is this a problem?

#6 Cracked culvert. Close up of #5 culvert

H-10	Trash and green slim in water and along edge beside storage units.	Conservation will check and put on list for cleanup	
M-13	Air conditioner on side of road near culvert on Broadmeadow Rd.	Conservation will add to cleanup list	(need to check if it was removed)
<b>NE Marlborough Stream Study</b>			
C-5	Culvert near Goodail St. rocks above pipe are cracked	DPW to be notified-

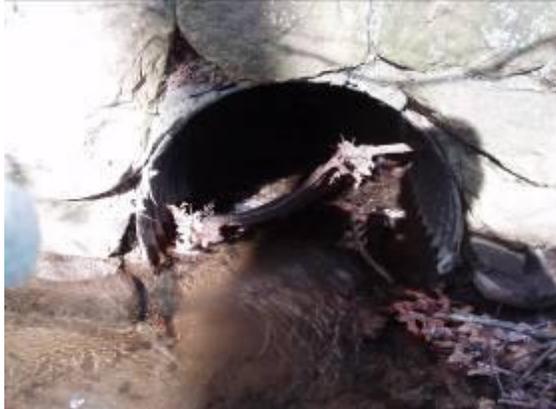
#13 Hemenway Ext Broken SE culvert

Conservation will check.	
B-8	Hemenway St. extension pipe is rotted out, base of culvert is broken off	DPW to be notified	
D-6	Culvert at Sudbury St. Rocks are shifting	DPW to be notified	
F-12	White foam from drain pipe near Hanlon Dr. cul-de-sac	DPW to be notified	Samples taken, DPW is investigating an illegal drain connection (possibly washing machine connection.) Abutter also reported this.
G-11	Undercut/ crumbling/ breaking concrete siding in this channelized section	DPW to be notified	
F-11, F-12, G-10, G-12	Trees have fallen across brook, may cause blockage over time	DPW to be made aware of this. Removal only recommended if it becomes a problem.	
F-6	Unclog culverts in section F-6 off of Grogan Path (front corner of properties 22-107 and 22-108)	DPW to be notified	
F-5	Unclog culverts in sectionsection F05 off of Jean Road (between property lines 22-28 and 22-38)	DPW to be notified	
E-6	Unclog culverts in section section E06 Blanchette Drive (property 22-91 and across the street 22-89 )	DPW to be notified

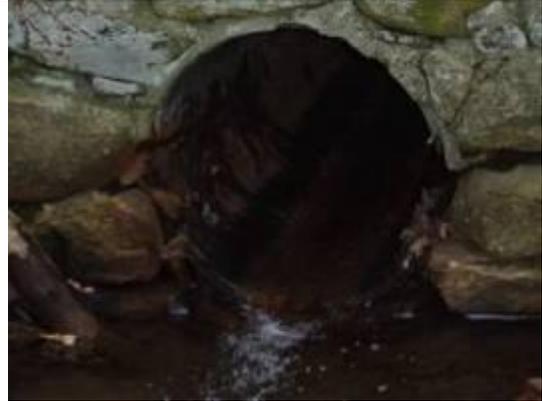
#14 B8 Culvert busted left side Hemenway Ext.

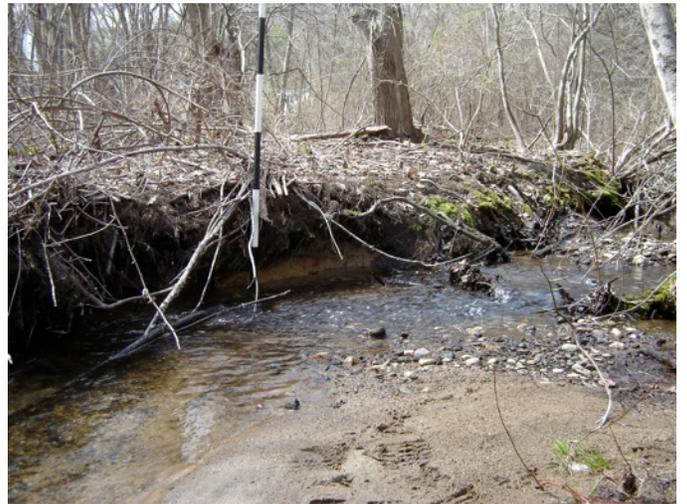
banking with erosion

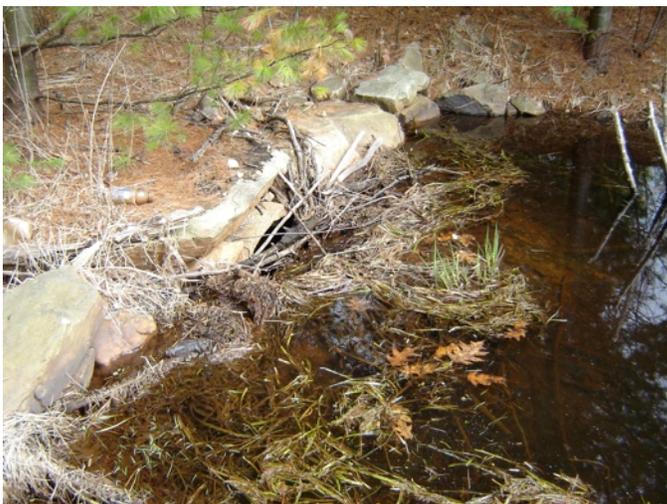
(photo below) other side of culvert (opening) almost completely clogged

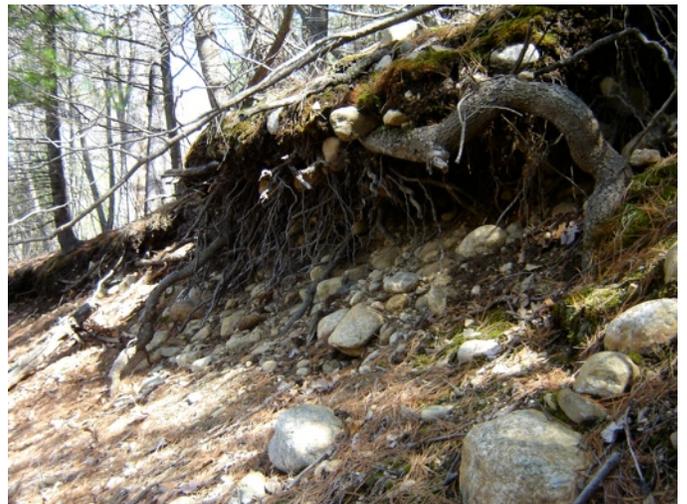
eroded banking

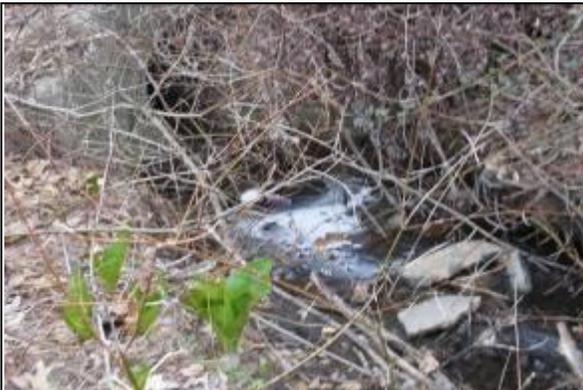
F11 Culvert Hanlon Dr. white foam
