# Stream Team Report

Marlborough Stream Team, December 9, 2008

## South Street and Sheep Fall Brooks Marlborough, Massachusetts

### Study Conducted November 2008

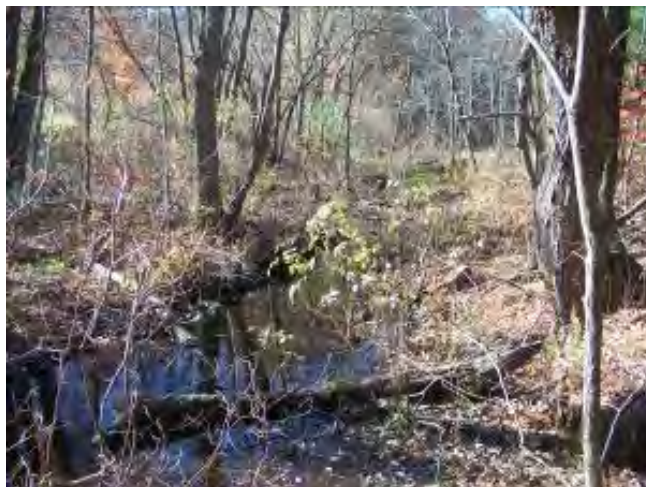
A3 Above stone culvert

We entered the brook from the cul de sac at the end of Varley Road. (B05). We had tried to access it from Pleasant Street - but after traipsing through thick underbrush, we finally reached a spot where we could no longer approach the brook. We then retreated and went to Varley entering the brook area through an abutter's yard. We descended down a good distance to reach the brook. The water in most areas was about 6" to 12" deep with natural river banks in good condition through-out. Brook bottom was muddy and leafy (time of year and presence of many deciduous trees probably responsible for this). Water was hardly moving. After a short distance, we merged onto a good path (with access coming in also from Matheson Circle) and headed north. We passed two (2) sewer access points. Land to the west sloped upward; land east was wooded. Continued through B04-B03. Went across a well preserved cinder block crossing over a smaller brook running east-west. We continued north well into A03. Brook was not more than two (2) feet across at any point. Passed through a wooded area where there was a hunter's blind. We must have been fairly close to Route 290 since the sound of cars was quite distinct. Just prior to the end of A03, land to the west was ledge. There was a rock culvert here in good condition on our approaching side... but pretty well collapsed on the side where the brook was moving into a heavy, swampy area full of reeds. The collapsed culvert appeared to possibly hamper water flow.

<b>PRIORITIES</b>	Fixing stone culvert that collapsed (A3) for better stream flow
-------------------	---

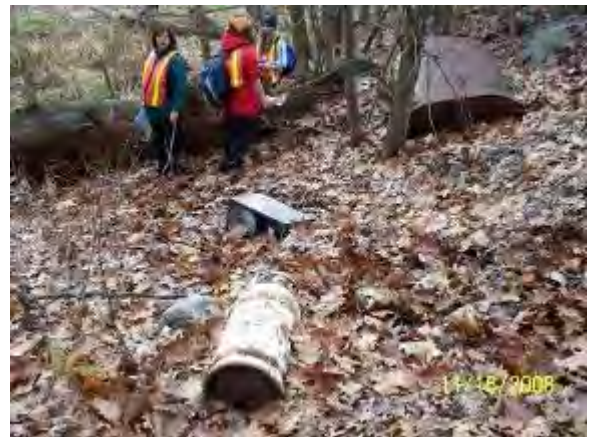
A06 Propane tank, microwave, rusted tank behind Moose

- 1) Pool and feeder stream strongly smelled of sulfur in A06 (see photo)
- 2) Remove trash behind Moose a television, air conditioner, large propane tank, tires, and beer can and tires near Pleasant street area
- 3) Remove trash upstream behind Land's Towing (Fitchburg St.) lots of pollution in, on and around the stream - a fire extinguisher, tire, plywood, cooler and large pieces of debris on the hill. Swampy and LOTS of pollution.

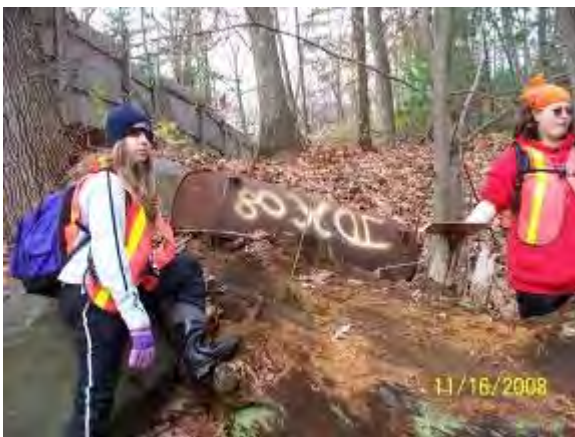
A06 rusted tank behind Moose

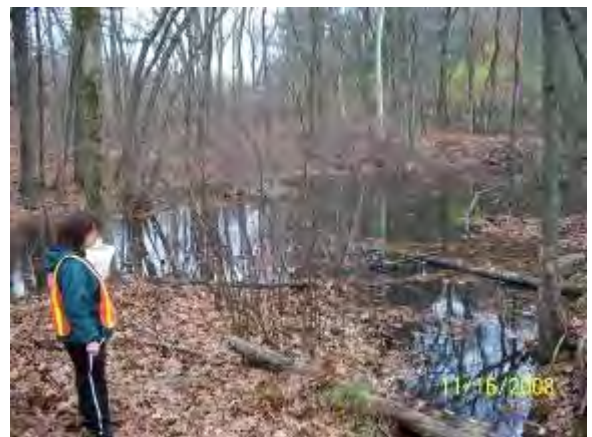
A06 Behind Moose and across stream... this pool and feeder stream smelled strongly of sulfur.

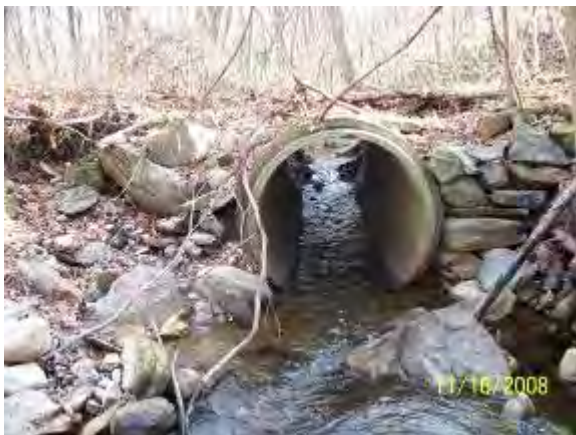
We observed some yellow foam, and a large tree down in the stream but not blocking the flow. There is overhanging vegetation. There is a concrete pipe. The girls walked through it and said it smelled like baking soda when they were in there. It was in good condition. We passed through at 2pm and there was a moderate flow about 6" deep in the pipe. Downstream outside the pipe the water was more than a foot deep with a sandy and boulder stream bed. Upstream of the pipe possibly an animal habitat to the side of the pipe, muddy right bank with woods on the left bank along with vines and sand. We observed crows flying above us. Toward the far end of the townhouses upstream we saw a metal pipe 13" in diameter draining into the stream. The bottom of the pipe is corroded and rust staining below on the bank.

C07 Concrete pipe, good condition,  
smelled like baking soda

C7 (Behind town houses on Ash St./Pleasant St.)	Toward the far end of the townhouses upstream we saw a metal pipe 13" in diameter draining into the stream. The bottom of the pipe is corroded and rust staining below on the bank.	<b>DPW will be notified as to condition of pipe and will determine if anything needs to be done.</b>	<b>1/29/09 DPW notified</b>
C7 & D7	Pipes near 84 Ash Street and 29 Russell Street empty into stream	<b>Con. Com. has already confirmed these are city drain pipes.</b>	<b>Done</b>
D9 – E9 Russel St. culvert	Trash includes shopping cart and tire and cement blocks	<b>Con. Com. will inspect and add to cleanup list.</b>	
C7	Educating abutters about stream and watershed care. Ash Street runoff goes directly into stream. Prevent untreated road run off from emptying directly into stream	<b>Con. Com and DPW will work together on this.</b>

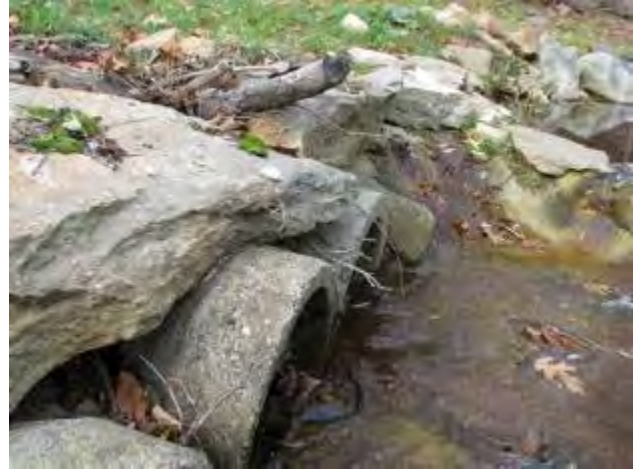
D9 Set of 3 culvert pipes by Retention Pond

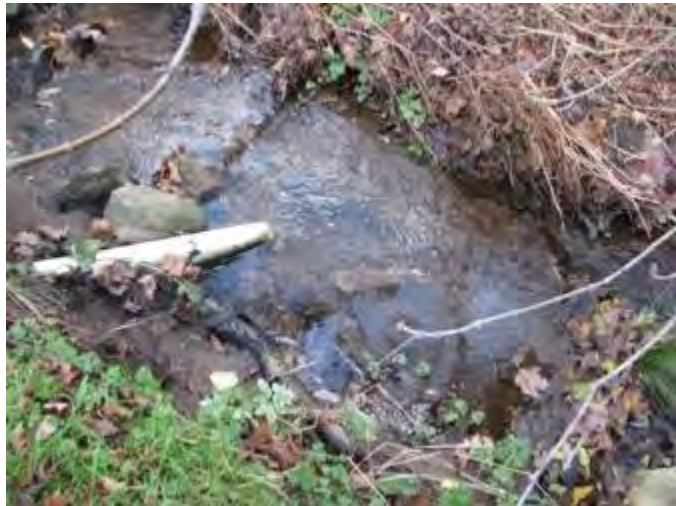
White drainage pipe was from the yard behind 29 Russell Street in the Stream

<b>PRIORITIES</b>	Educating abutters about stream and watershed care Preventing road run off from emptying directly into stream
-------------------	--

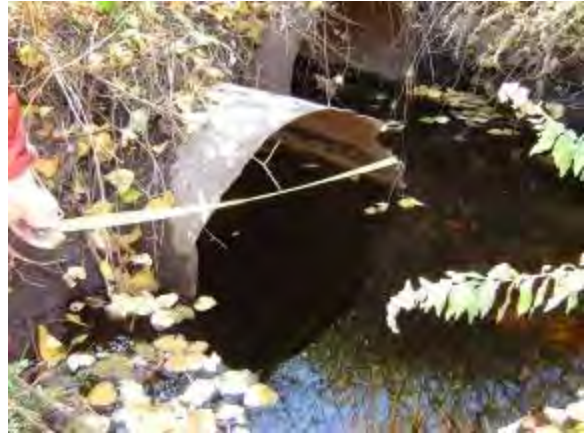
This photo shows one of the pipes sitting much deeper, and more submerged than the other. The overgrowth here had thinned out considerably, and although the water was too deep to walk in, it soon lessened and we could walk in the brook once again.

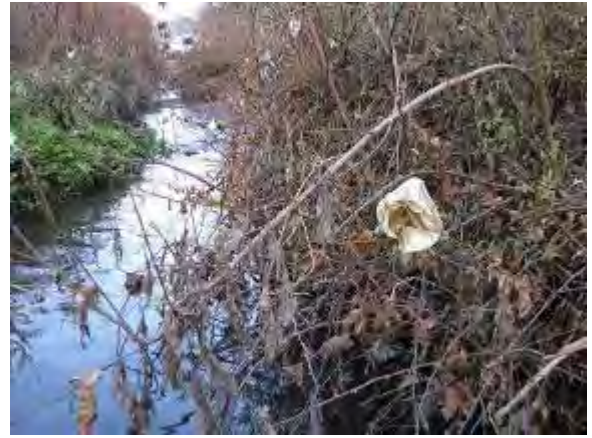
Debris hanging on vegetation gets caught there after North Branch of South Street Brook rises, showing recent high flood stage. Flooding, due to storm water runoff, deposits refuse in **A-11** behind 91-95 Neil Street area.

After water recedes, debris remains on vegetation lining North Branch of South Street Brook in **A-11** behind 91-95 Neil Street area.

1) Address rapid flooding of private property adjacent to the drain pipe openings, recommend extension of piping in **A-11** downstream to DPW garage property. Because the swift, powerful current is capable of dragging in nearby objects, it is a safety issue.

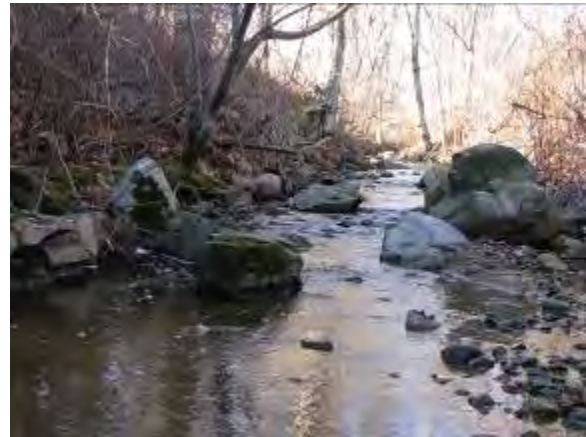
At the headwaters of the North Branch of South Street Brook in **A-11** dense vegetative stalks overhang 5' round diameter pipe at center of photograph. A smaller drain pipe is at far right. Oil slick is in foreground at right.

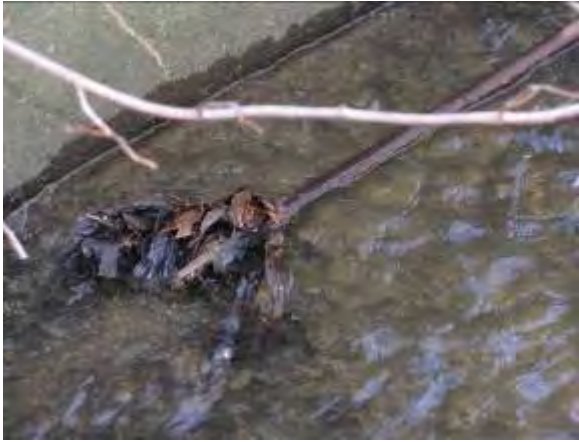
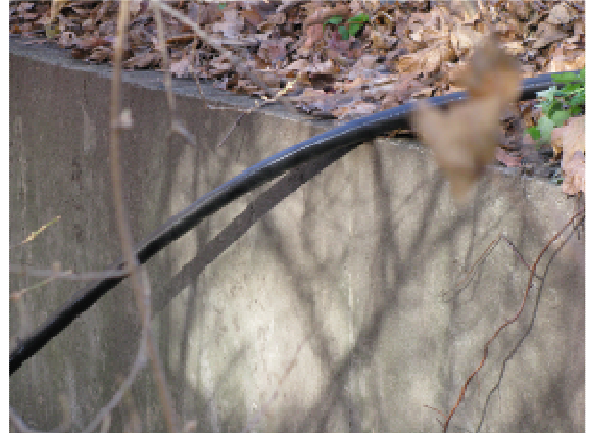
This pipe is connected to a long black rubber hose leading from a yard at 354 Maple Street. It is in the channelized segment of the North Branch of South Street Brook in **D-13** adjacent to the medical/professional building at 340 Maple Street.

Beside this channelized wall of the South Street Brook is a black rubber hose from a backyard behind the gray house at 354 Maple Street in **D-13**. The hose goes under and through a wooden planked fence, down a steep bank and into the Brook. In the yard is a swimming pool and a piece of construction equipment.

D13	a long black rubber hose going into Brook from 354 Maple Street (see photos)	<b>Con. Com. will investigate in spring 2009</b>	
D13	Composting near Brook (see photo)	<b>Con. Com. will send letter to owner to educate and suggest alternative location.</b>	
D14	A cement channel wall segment is leaning, leaving gaps (see photo)	<b>DPW and DCR will be notified of this condition.</b>	
C13-D13	Clean up pond behind Monty's.	<b>DCR will be notified. Area will be put on cleanup list for Clean Sweep (If permission granted by DCR).</b>	
D14	Remove blockage in channel (trees and organic debris).	<b>DCR will be notified.</b>	
E14	Walker St. Bridge – remove	<b>DCR and DPW will be</b>
