Stream Team Report

Various Streams Marlborough, Massachusetts

Study Conducted April 2010

Compiled by: Priscilla Ryder (with help from Jen Boudrie)

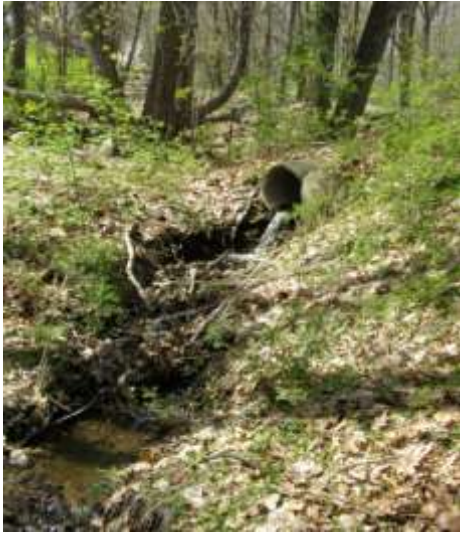
This photo shows a good example of a hanging culvert exiting the pond and going under Boivin Drive. About 40% of the many culverts we saw along this stream system were hanging culverts. Most culverts were cement and in good shape.

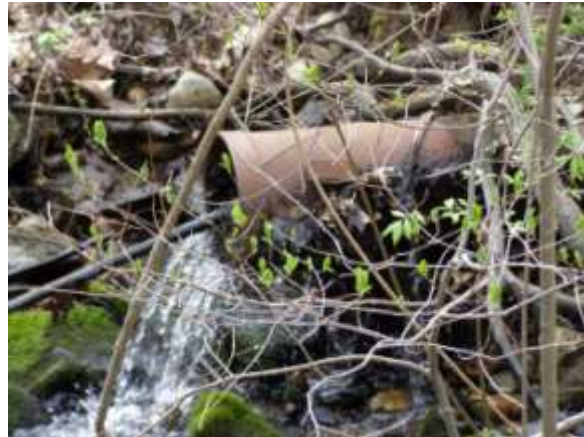
Further downstream we encountered a corroded metal culvert (N 42 20 122 W 071 31 953) with lots of holes in it – the water flowing through it was clear. Coming out of this culvert was a one inch black plastic hose which then ran downstream mostly in the middle of the streambed for a great length (many hundreds of yards) about where the gravel drive near the gated red house is. Also near the gravel drive we found an abandoned cement culvert by the side of the stream.

Stream section	Problem Identified	Assigned to:	status
Stream 1			
Section: D-05	The corroded metal culvert with black hose exiting and running in streambed for a great length. . Construction waste along eastern edge of pond in D05.	Conservation Commission will investigate these pipes and determine if they are a hazard. If so efforts to have them removed will be taken.	
Section: E06	Sewer type pipe in streambed near Farm Road	Conservation Commission and DPW will investigate	
Sections:C6,C5,	Hanging culverts- most of the culverts observed in this section have hanging culverts	Conservation Commission is now aware of this, when repairs are made to these structures – this will be addressed.	
Stream 2			
Section B-2	Beaver activity at Jericho Hill pond outlet	Conservation Commission to investigate and work with DPW	DPW notified in summer 2010, clogged outlet was addressed. Ongoing monitoring needed to resolve problem.

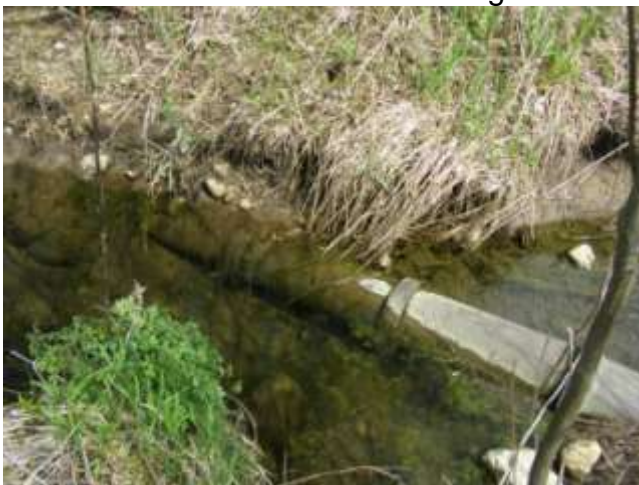
Across Farm Road on the reservoir side there is a metal or ceramic “sewer” pipe in the streambed – it seems to begin at a substation off Farm Road (E06). We can’t follow the stream into the reservoir this area was far too overgrown.

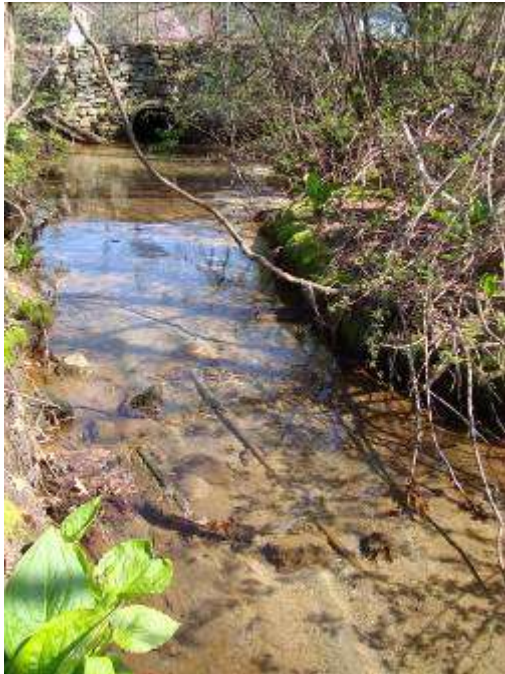
A short stream starts under Hosmer Street, flows by Memorial Beach parking lot and empties into a wetland east of Causeway Street Extension. The culvert under Hosmer Street looks OK, but there is an unknown 1" pipe in middle of stream nearby (photo left).

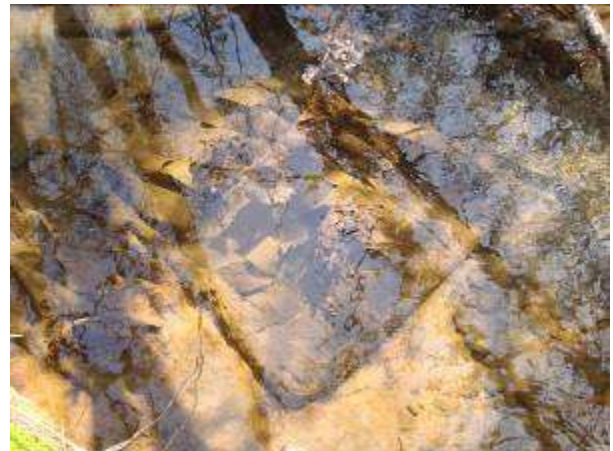
There is some dumping in the stream (photo right) and in the parking lot.

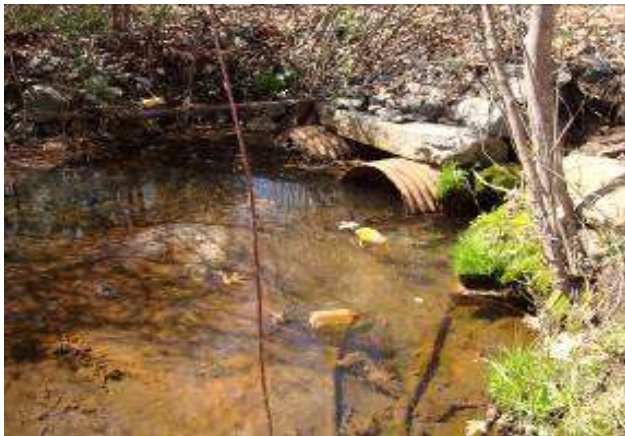
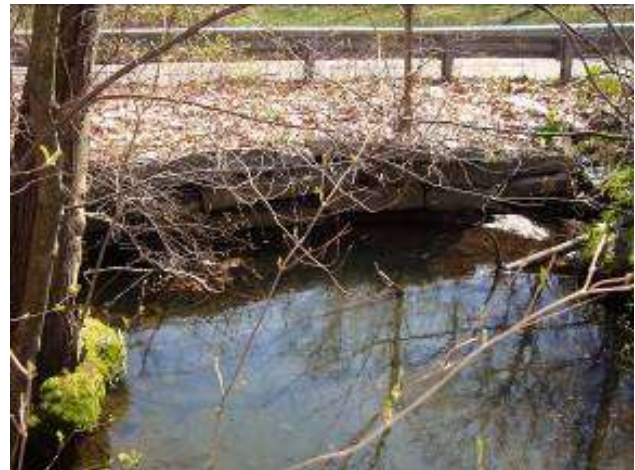
The stream flows under Causeway Street Extension Road but the culvert is obviously clogged. The top of the culvert is visible (below left) on one side of the road, but not on the other side (below right).

Investigate vodka bottle dumping and unclog culvert where the stream flows under Causeway Street Extension.

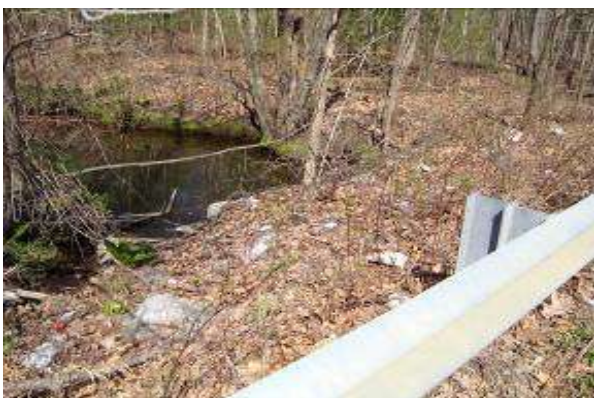
At this same location on Causeway Street Extension there are 75+ countable vodka bottles (photo left) likely tossed there by a passing driver from the nearby road. This was reported to the police & conservation department.

Stream 3			
Section: B-11	Vodka bottles dumped next to Causeway Street Extension at brook crossing.	Conservation Commission to follow up with cleanup and if continues contact police again.	
Section: B-11	Unclog culvert where stream flows under causeway street extension	Conservation Commission and DPW	Beaver activity was found in this area, and the beavers have been actively clogging the culvert. In Fall 2010 DPW did some unclogging, this will need to be monitored regularly- as the beavers can be persistent. A beaver

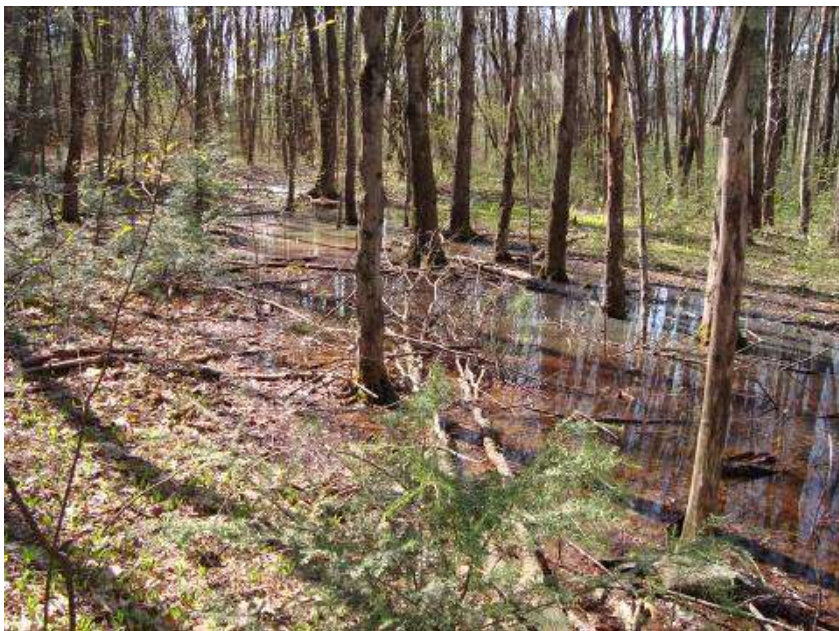
There was some discolored stagnant water in the woods below the old house at the end of the long drive way. It was hard to tell if it was road run off or natural discoloration. It was a bit milky in one area and greenish blue in another.

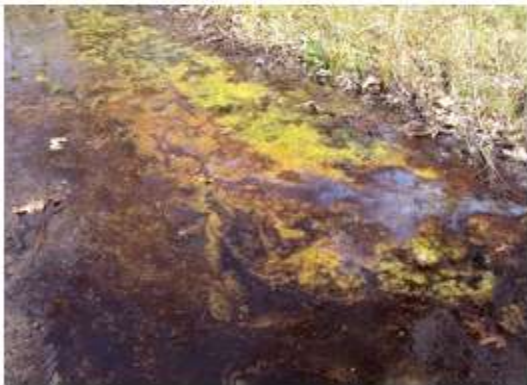
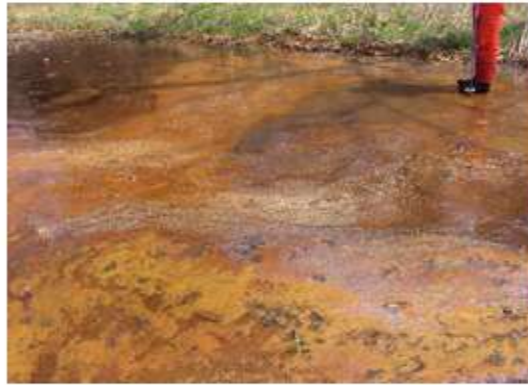
Area B11

Small pond between Hosmer St and the Memorial Beach parking lot. Pond water appears to overflow or leak onto parking lot, creating unusually colored wetness.

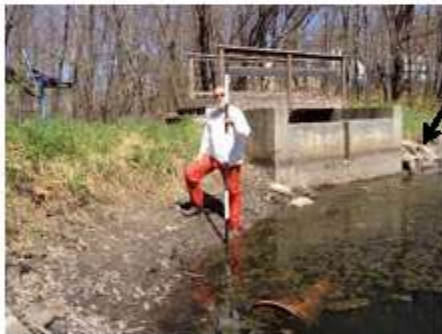
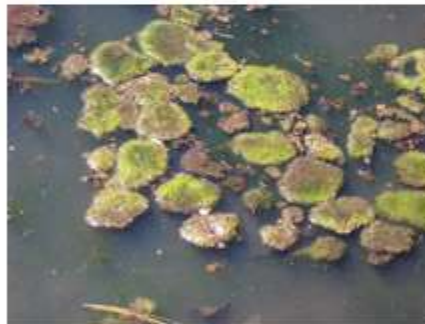
... water level of pond seemed about 2 ft. lower than "water stain" on concrete "dam" ... one side of concrete structure appeared washed out by earlier rainy period and remedied by sandbagging also abundant plant growth covering water's surface ... much litter as well ...

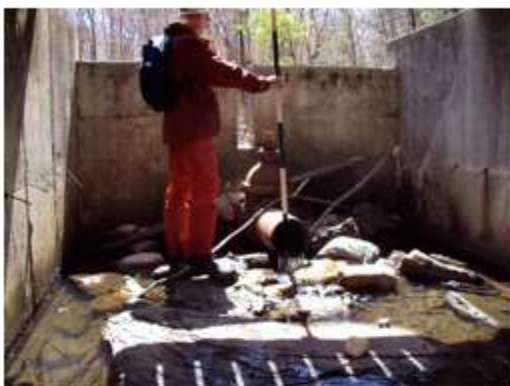
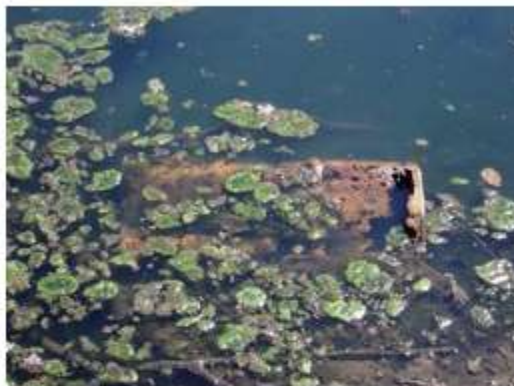
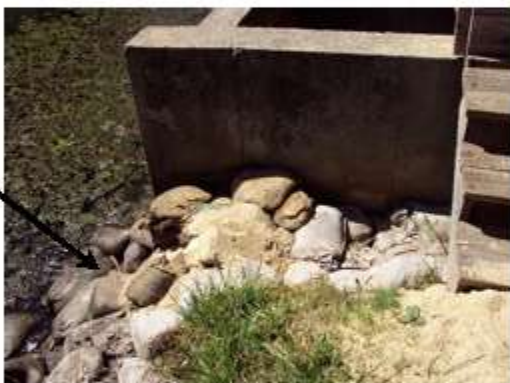
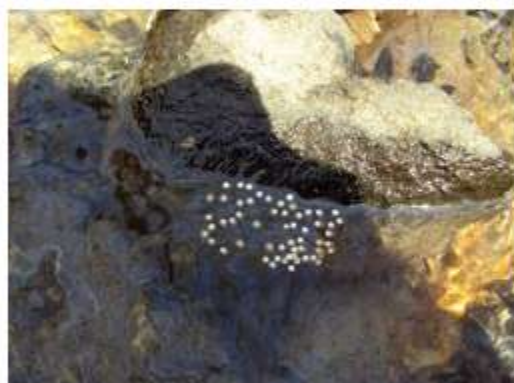
exit pipe from pond (small fish spotted in water) trash & algae at pond's edge

dam's edge sandbagged to fill washout eggs in stream that leads away from dam ...

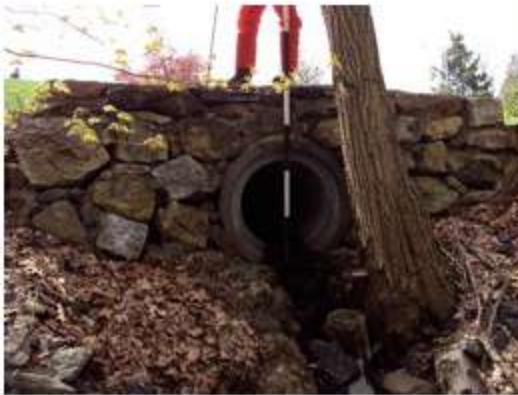
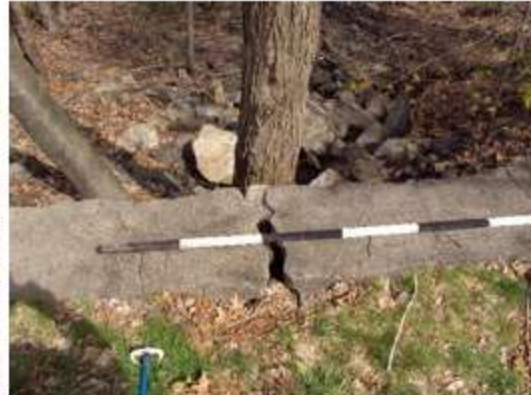
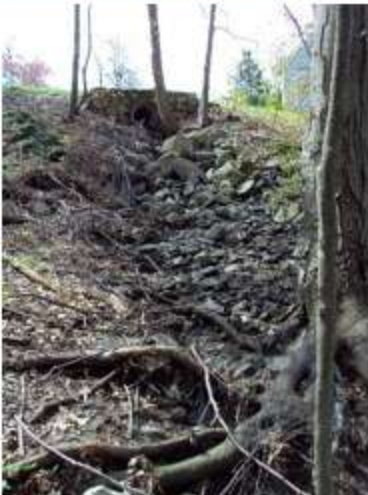
Areas E08, E09, and D09

Culvert in Area E08, at the very end of Ridge Road, and the cracked cement encasement covering. Steep gradient.

- clean downed trees at culvert opening & clogged culverts on Kings Grant Road. (H06)
- check out cracked culvert encasement at end of Ridge Road (E08)

Section: H-06	Clear downed trees at culvert opening and clogged culverts at Kings Grant Rd.	Conservation Commission will work with DPW to address	
Section: E-08	Check out cracked culvert encasement at end of Ridge Road	Conservation Commission to work with DPW to investigate	
Stream 4			
All sections with trails	ATV activity through some of the trails near the brooks	Conservation Commission will investigate	Commission contacted state environmental police in summer 2010, investigation and enforcement is underway.

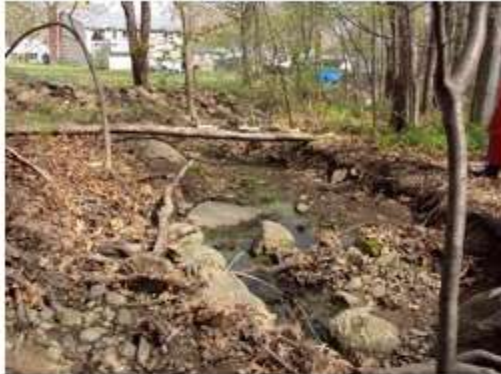
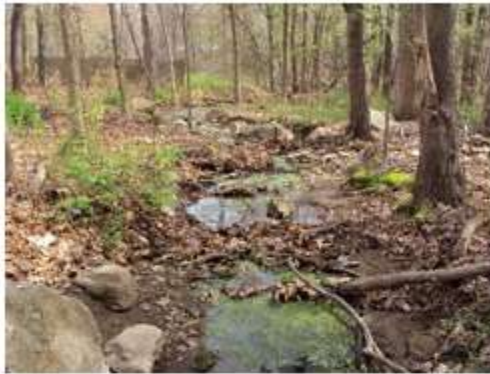
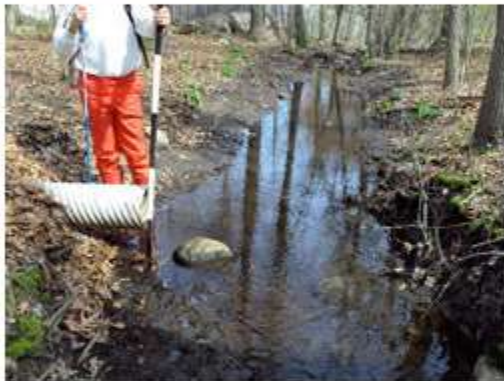
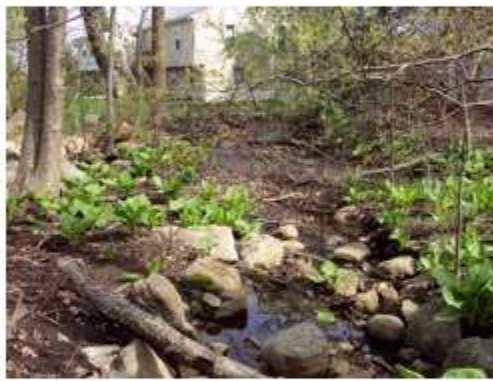
evidence of bank erosion after recent heavy rains ... stream continues past backyards on Stevens St. some green algae in the water at this point

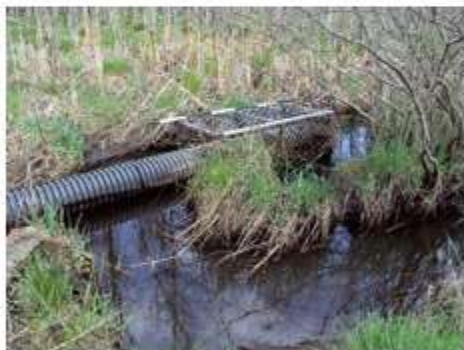
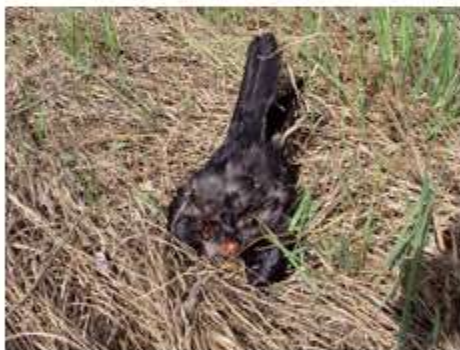
strange device and headless crow found in the wetland
