# Stream Team Report 2009

- Broadmeadow Brook
- Hop Brook
- North East Marlborough Streams

*Study Conducted April-May 2009*

June 2009

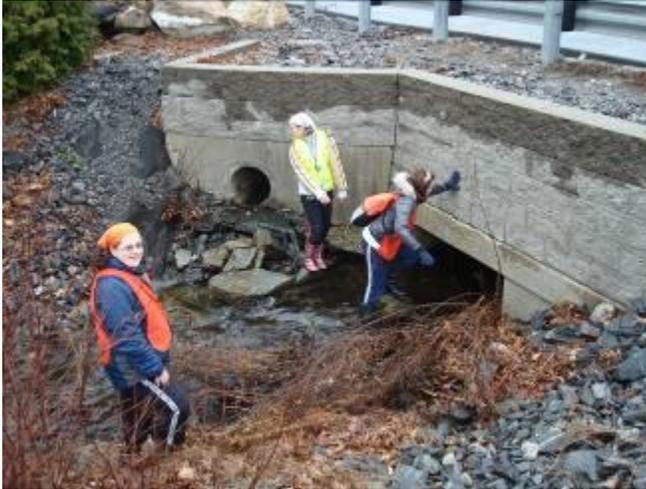
Start of Stream; pipe 18" diameter under bridge  
61" opening across

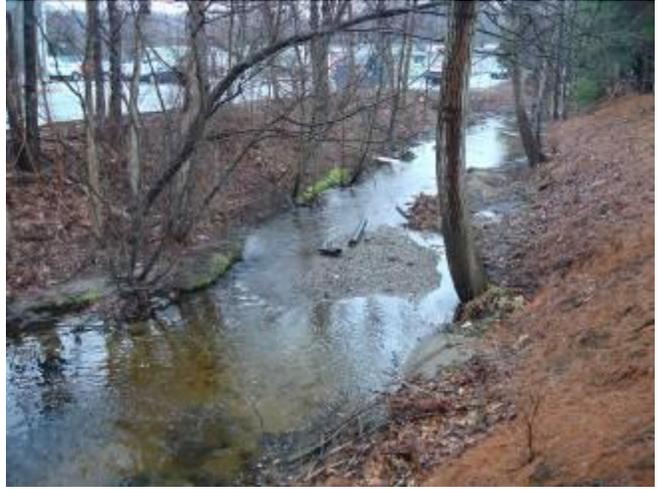
At start of stream Jo-Len Trailer park to the right.  
Pipes in water

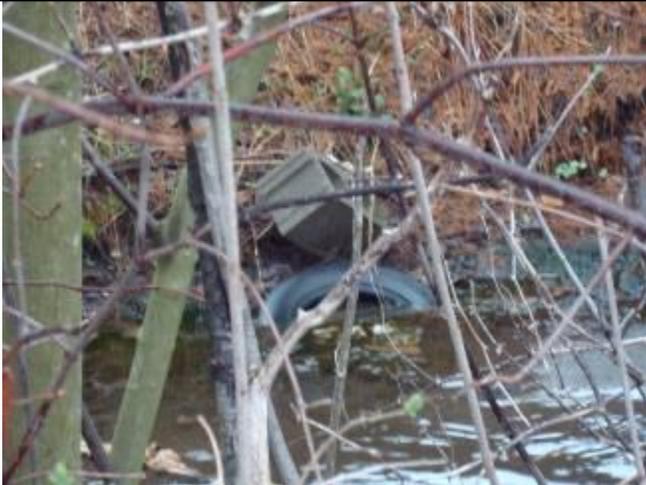
Trash in water behind Jo-Len

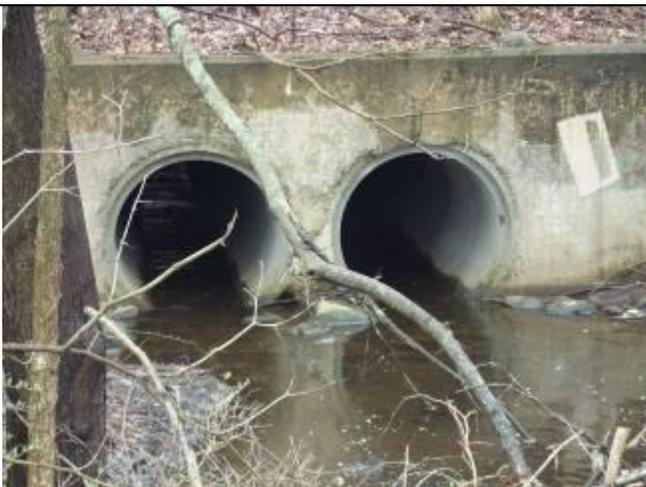
G14-at sewer easement...under the easement

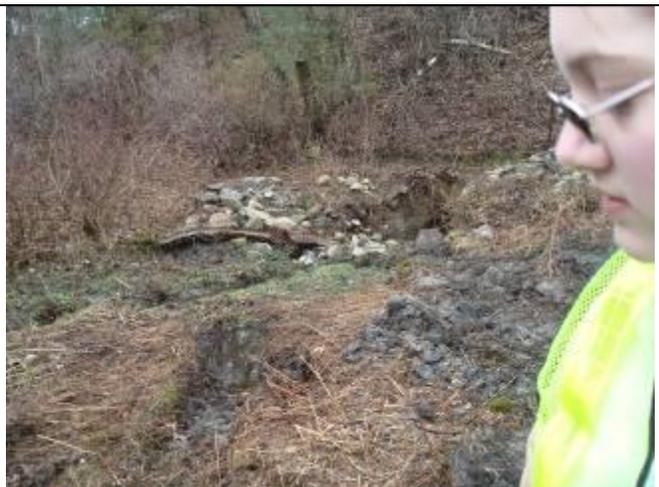
Pipe area behind 73-27 pond...DPW was opening  
this area up about 2 weeks ago

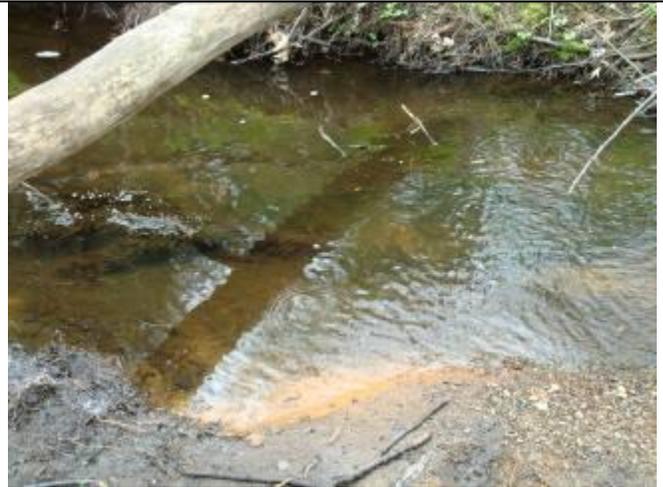
Vegetation in water – Algae?

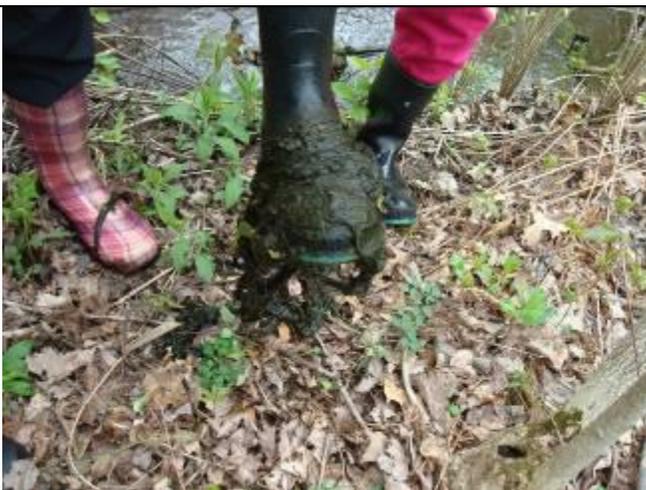
Vegetation on boot – Algae?

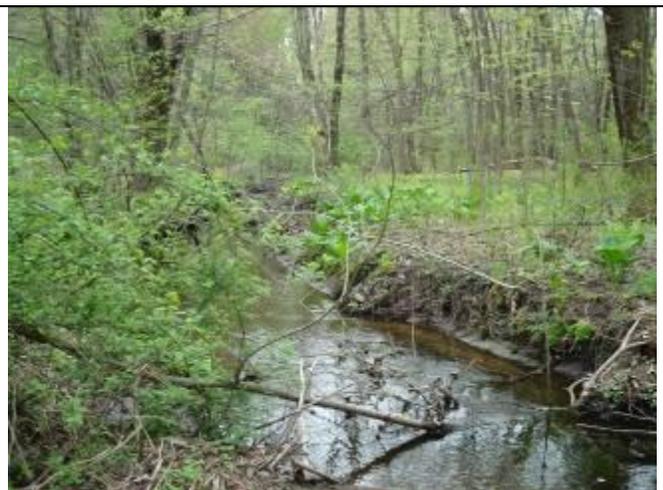
Right bank undercut - View downstream

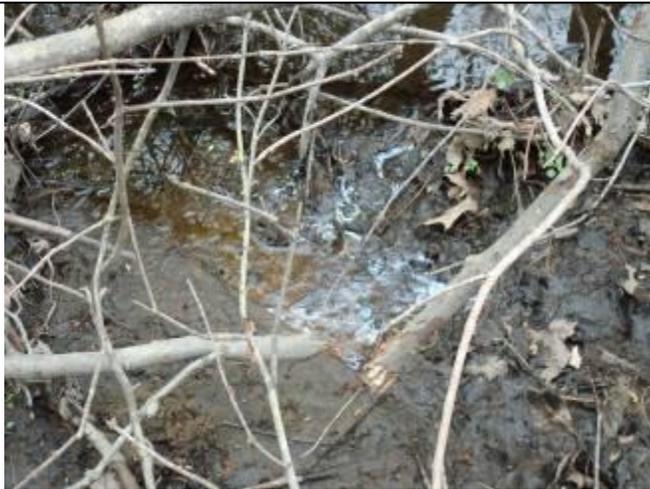
Oily residue observed throughout our survey from start to finish. There was not an odor of oil present. Helen Drive resident was concerned about people damming up the steam to gather crayfish.

Oily material

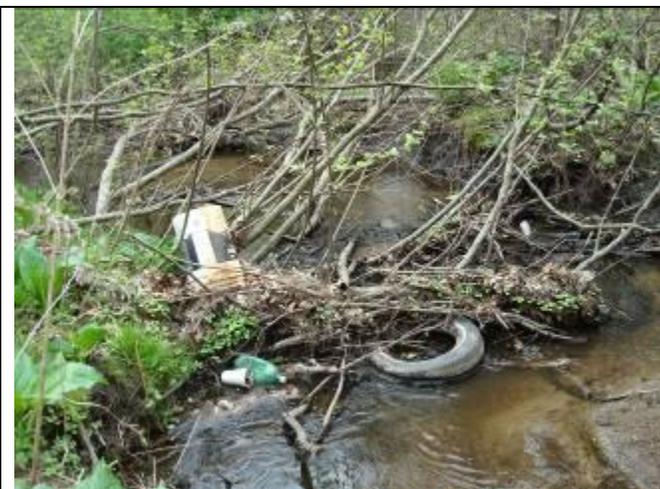
Trash

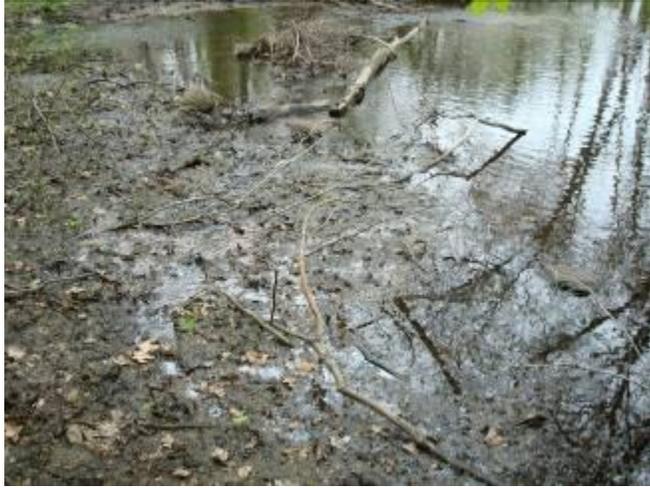
More oil in the water

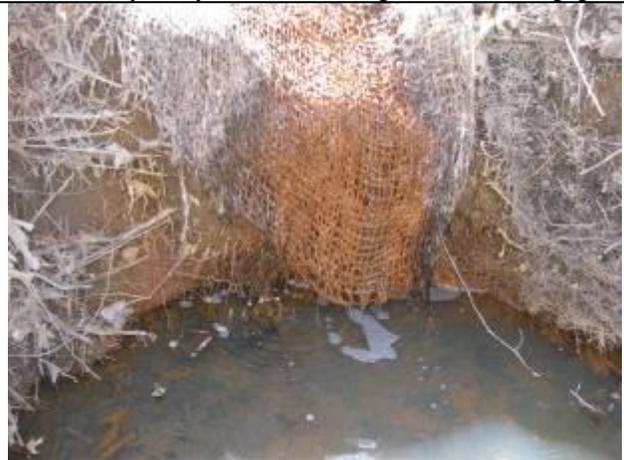
I13 Sisal netting

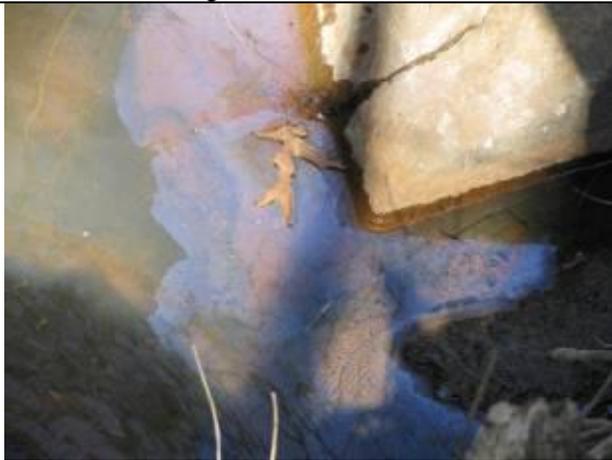
I13 Oily water near sisal netting

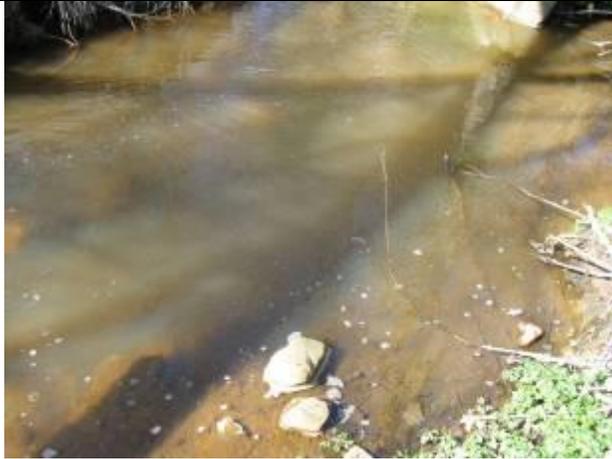
On the other side of **Boston Post Road**, along the perpendicular **DiCenzo Boulevard** in **H13** near **I13**, the water flow disappears before going under Route 20, but before it does it is a very nasty orange, rusty color (see Photos). It is gunky and oil-looking with blackened oak leaves on the bottom. Further away from Route 20, closer to **I13**, sisal netting/ jute matting has been pegged along the steeply sloping brook where the water is orange (see Photos). Trash bags, planters, beer cans, styrofoam cups, a pipe section and automotive body parts are scattered in the rosethorns and long grasses. Next to the steep embankment between the brook and **Dicenzo Boulevard** is a stand of pines and landscaped lawns with pesticide warning signs. Down in the ravine is an 18" pipe filled in with branches, skunk cabbage, and trash.

H13 Brown milky polluted waters

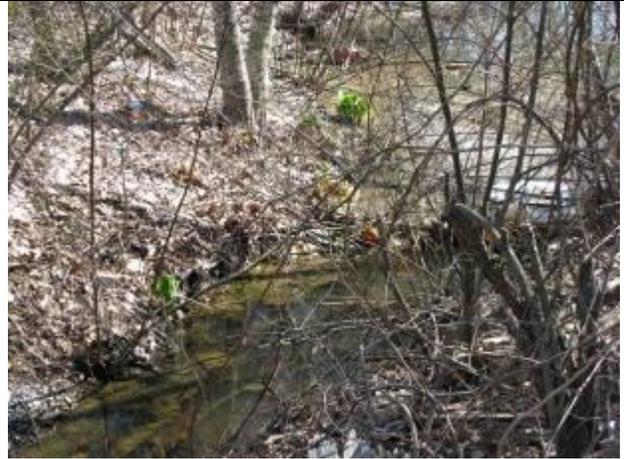
H13 Polluted waters

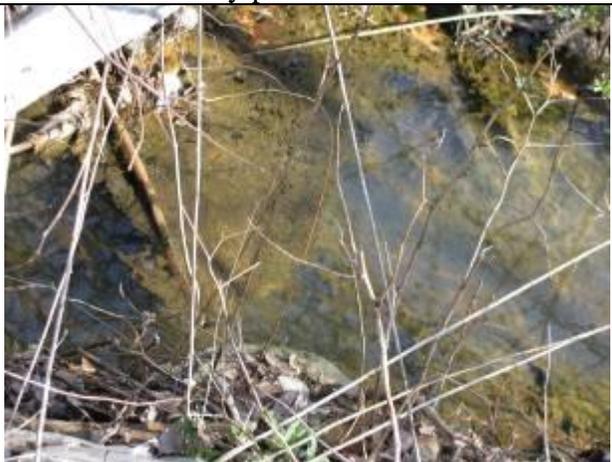
H13 Thick green algae

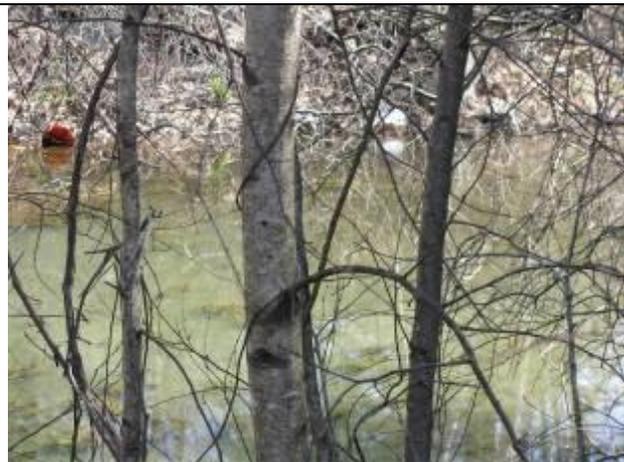
H13 Thick green algae #0971

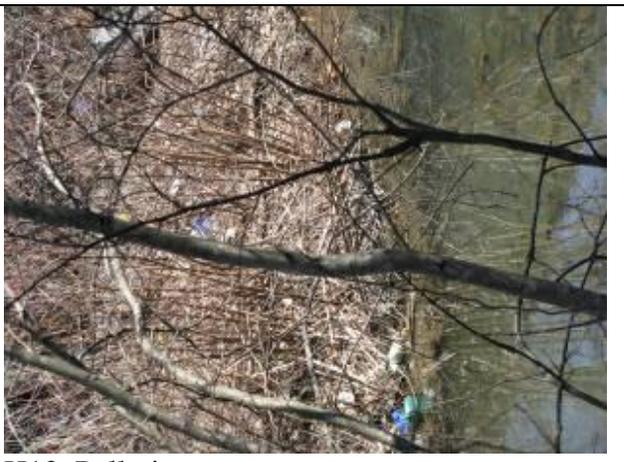
H13 Pollution

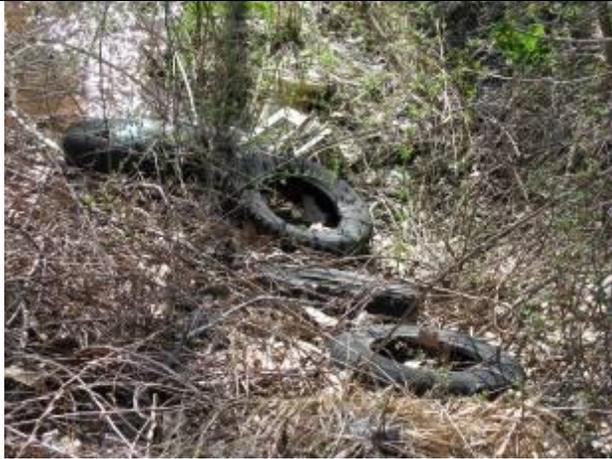
G13 Trash

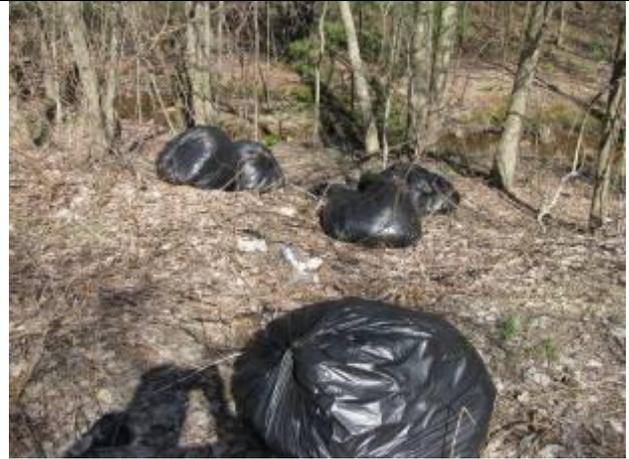
G13 Abandoned trash

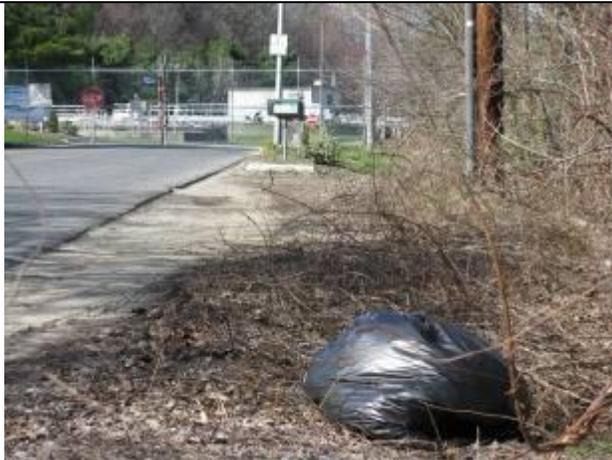
Along the driveway to **Easterly Water Pollution Control Facility** in **G13** the rapidly flowing water becomes dirty and rusty riffles (see Photos). Closer to the entrance of the **Easterly Water Pollution Control Facility** are 7 bags filled with trash, 3 tires, an air conditioner, adult entertainment advertisements, and a bleach bottle along the moderately rapidly flowing orange water which (See Photos)

G13 Trash along roadway

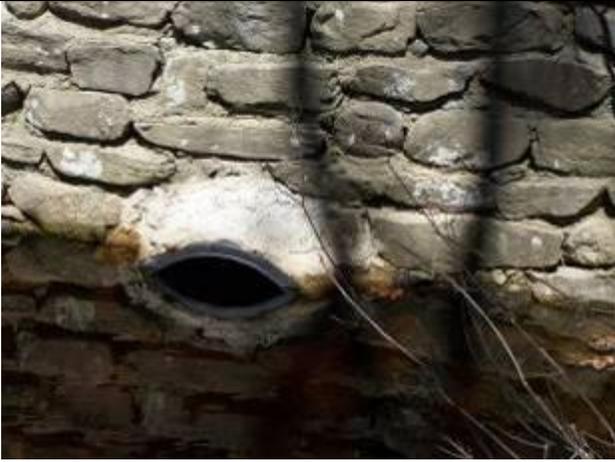
Just north of the parking area, we entered a broad stretch of marshland on the east side of the road. This area had a lot of newly sprouted skunk cabbage and moss. This area as well as the area we would next enter are actually outside the boundaries of our assigned stream zone. This area was too marshy to walk through so we followed this stream west, back under Broadmeadow Road through a culvert. We hoped to follow this to connect to the Hop Brook Stream section that was part of our assigned territory of the map. The roughly 18 inch-culvert was made of stones cemented in place, and was in good condition. There was evidence of erosion from the road and there were sandbags to restrain the flow of the dirt. There was only a small amount of trash on either side of the culvert; however, on the east side, there appeared to be a discarded air conditioner.

**Culvert on west side of Broadmeadow Road just north of the parking area. ( M13 )**

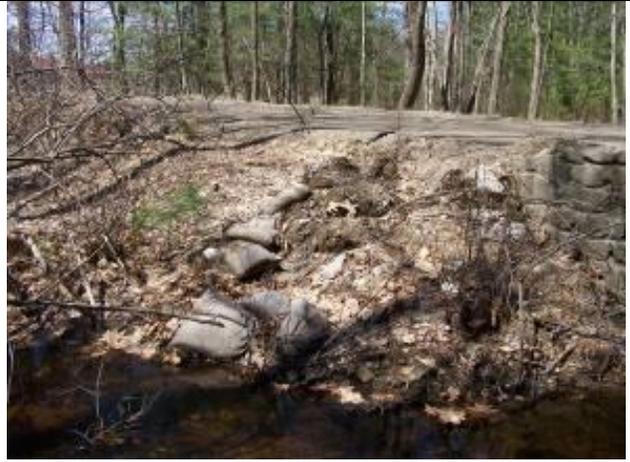
**Sandbags adjacent to above culvert ( M13 )**

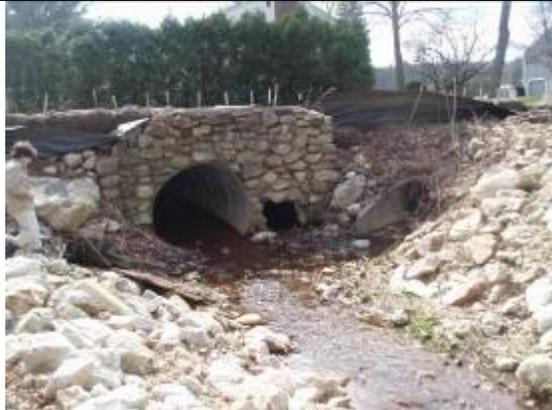
#5 C5 Four culverts

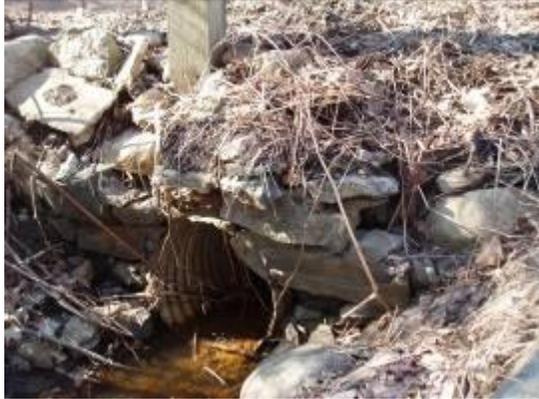
#9 C5? Concord Rd Culvert, rocks ready to fall

Assess culverts for damage.

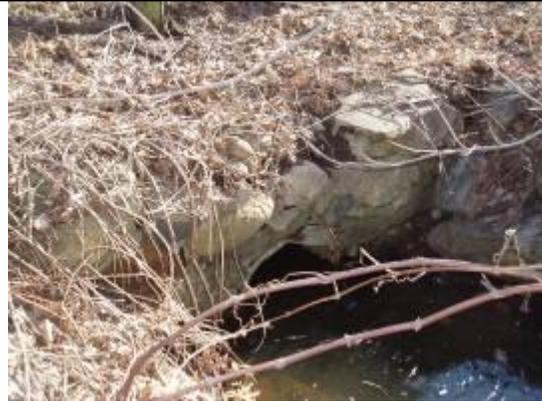
- C05 culvert near Goodale St.- rocks above pipe are cracking.
- B08 near Hemenway St. Extension- pipe is rotting out; base of culvert is broken off
- D06 culvert by Sudbury St.- rocks are shifting.
- Drainage ditch by Concord Rd./Sudbury St. intersection. When the water level drops in the summer, is this a problem?

#12 Hemenway Street Ext. Culvert NW

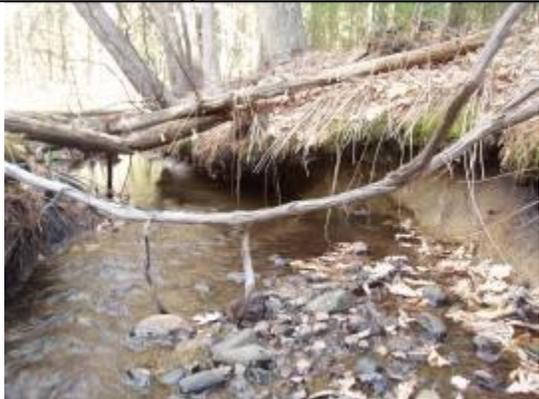
#15 Eroded bank

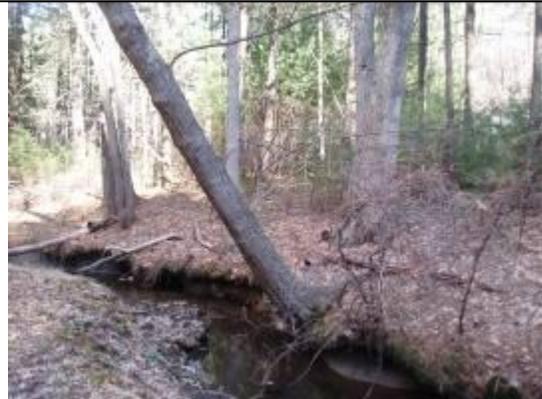
#16 B8 Eroded bank - undercut

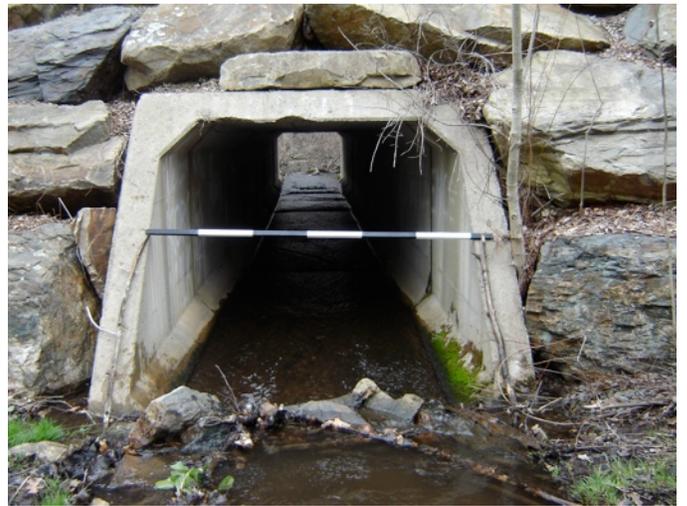
stream somehow makes its way through this

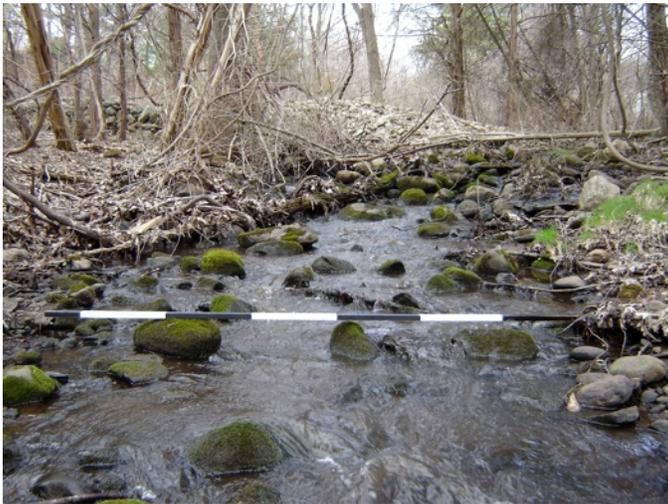
banking with erosion

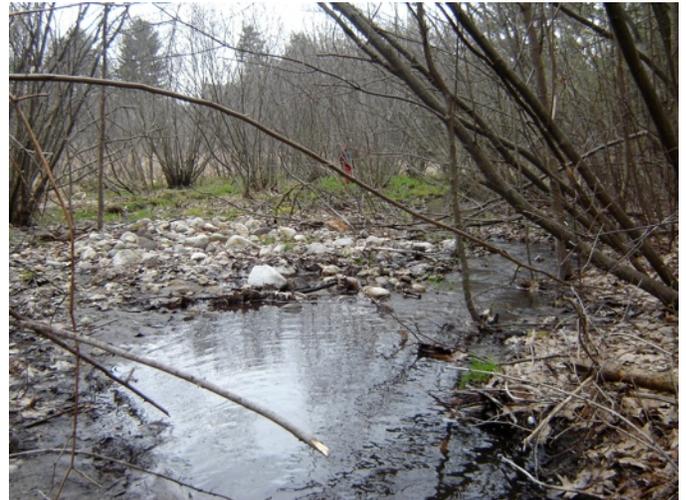
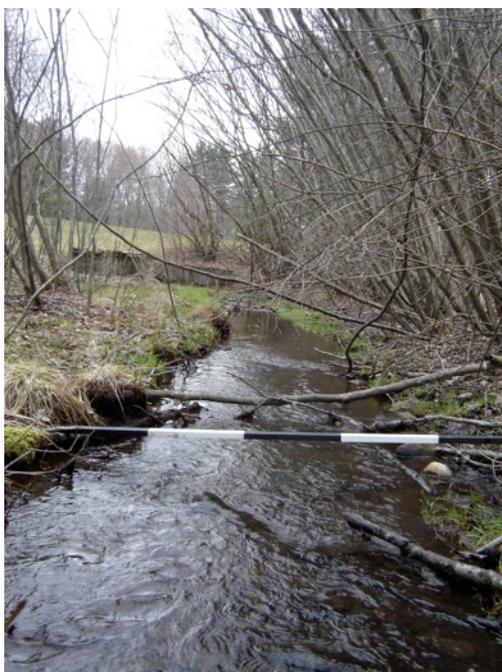
the main stream continued (photo left) and then eventually entered into an open wet area (photo below)

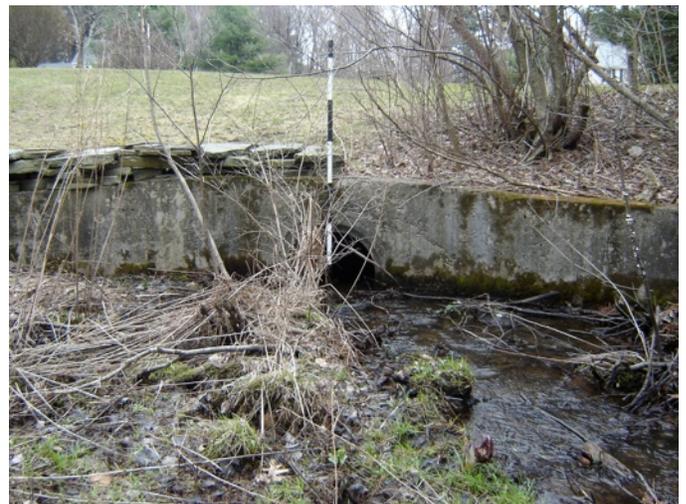
upon leaving the open area the stream appeared itself again (photo bottom left) and then emptied into this culvert just off Prendiville Way. (bottom right photo)

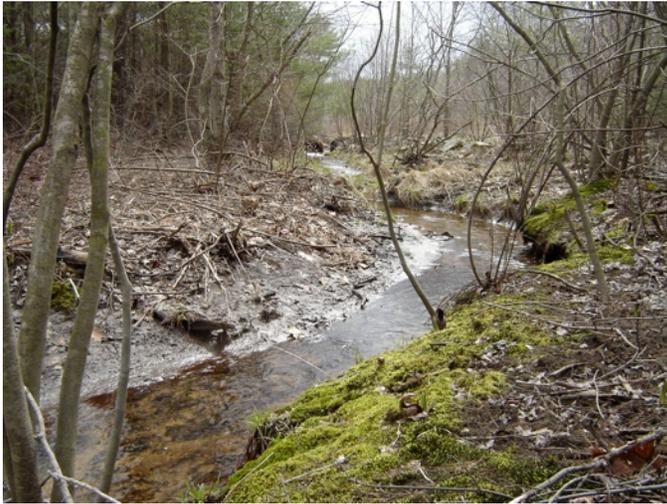
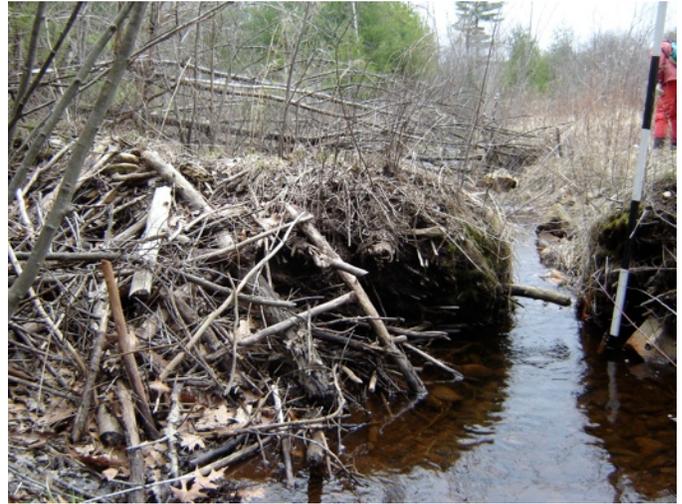
Beaver Stream as it enters Unnamed Stream # 1 (looking upstream) ... First Beaver Dam

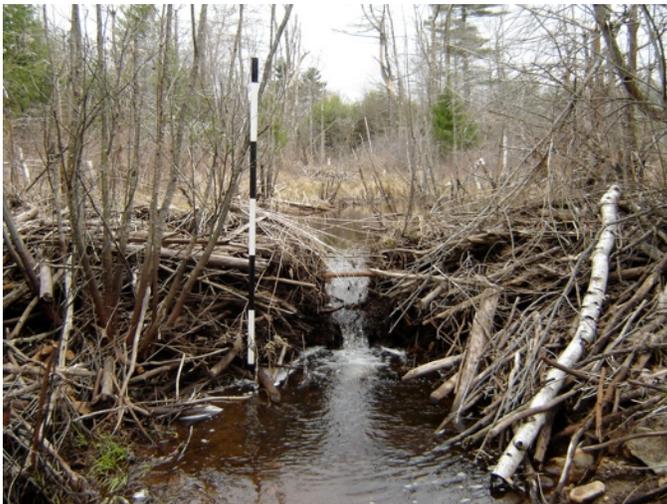
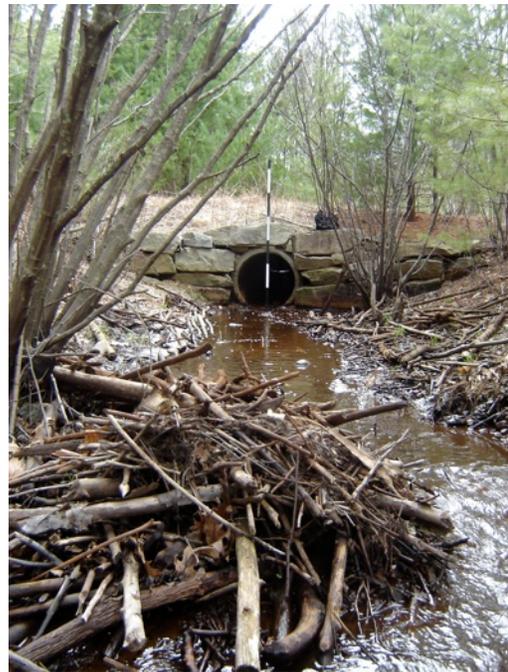
Second Beaver Dam (heading upstream) photo below

Unmarked (on map) culvert a few hundred feet upstream (photo right)

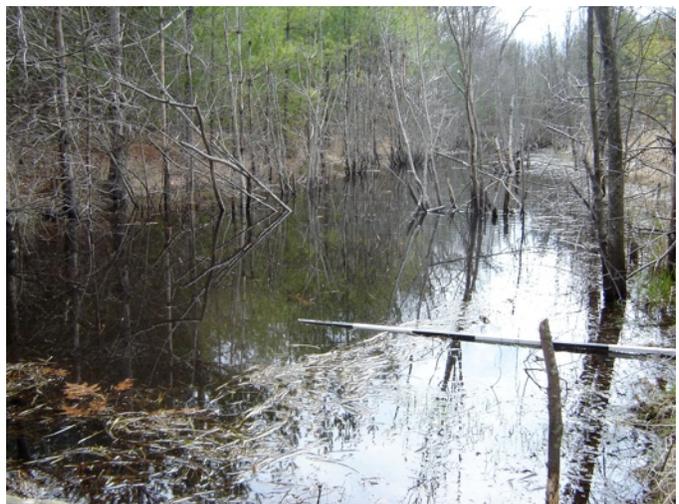
(photo below) other side of culvert (opening) almost completely clogged

(photo below right) resulting "pond" facing upstream and not far from Graham Path

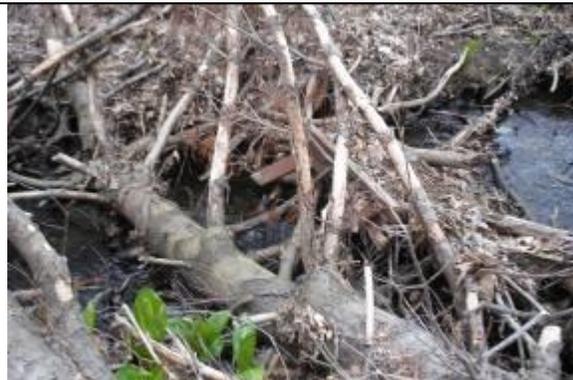
F11 Culvert Hanlon Dr. white foam

Conservation will check.	
B-8	Hemenway St. extension pipe is rotted out, base of culvert is broken off	DPW to be notified	
D-6	Culvert at Sudbury St. Rocks are shifting	DPW to be notified	
F-12	White foam from drain pipe near Hanlon Dr. cul-de-sac	DPW to be notified	Samples taken, DPW is investigating an illegal drain connection (possibly washing machine connection.) Abutter also reported this.
G-11	Undercut/ crumbling/ breaking concrete siding in this channelized section	DPW to be notified	
F-11, F-12, G-10, G-12	Trees have fallen across brook, may cause blockage over time	DPW to be made aware of this. Removal only recommended if it becomes a problem.	
F-6	Unclog culverts in section F-6 off of Grogan Path (front corner of properties 22-107 and 22-108)	DPW to be notified	
F-5	Unclog culverts in sectionsection F05 off of Jean Road (between property lines 22-28 and 22-38)	DPW to be notified	
E-6	Unclog culverts in section section E06 Blanchette Drive (property 22-91 and across the street 22-89 )	DPW to be notified

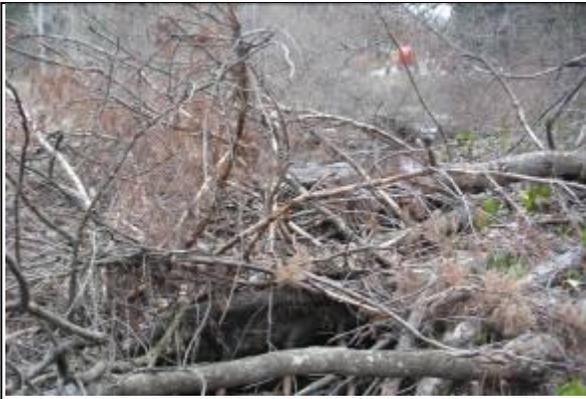
F12 Blockage Debris

1. Clean up/clear up fallen trees/debris in areas mentioned to help healthy flow of stream
2. Fix broken/undercut channel in G11

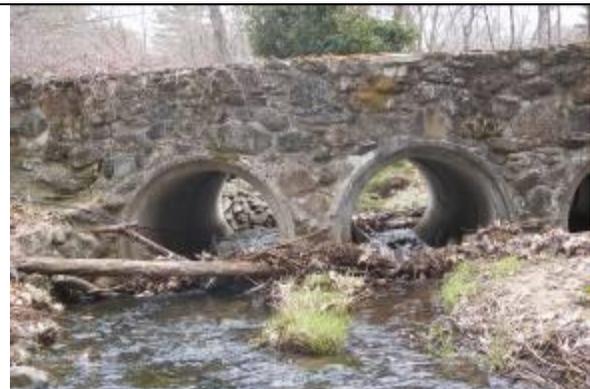
F12 Blockage. Couldn't go further.

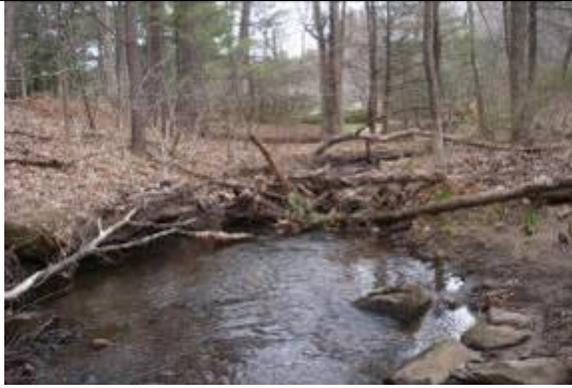
Into F11, the stream was broken up by a driveway/bridge. There was blockage in front of bridge over driveway. All thru this section was moss/algae on a clear, rocky bottom with fairly steady running water. Although slippery while walking through, it was a pretty clean, clear flow. We saw a red cardinal, and homes along side here. There were also heavy fallen trees/debris across one area that should be removed.

F11 Rock wall bridge driveway w blockage

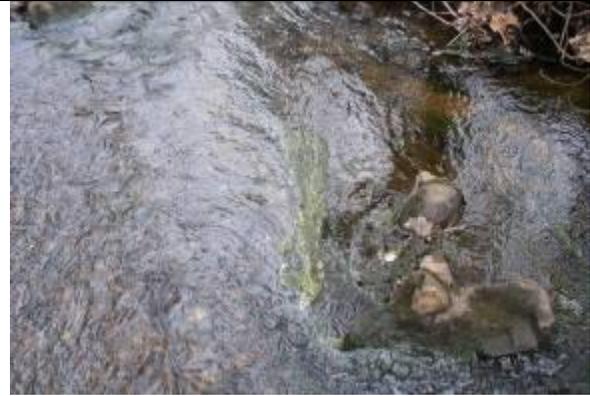
F11 Blockage

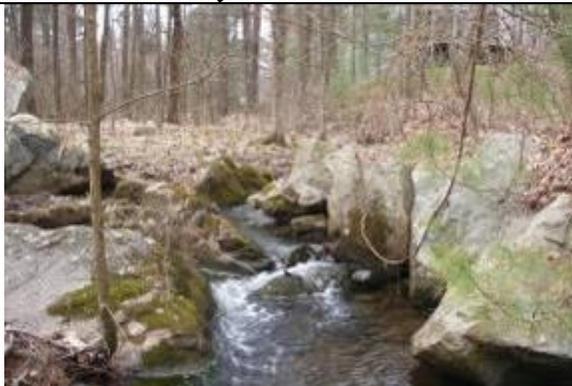
F11 Fallen Tree Across Stream

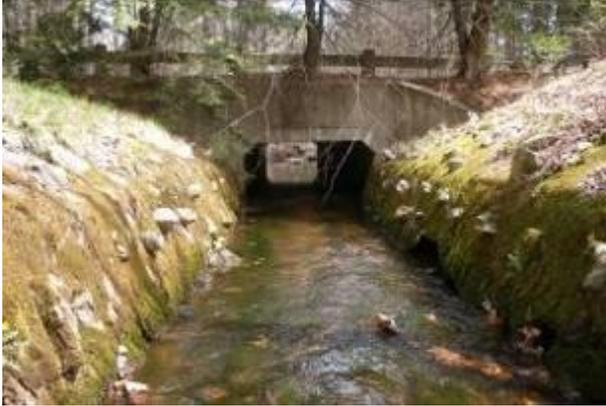
G11 Undercut Channel Breakage

G11 Channelized, Forsythia

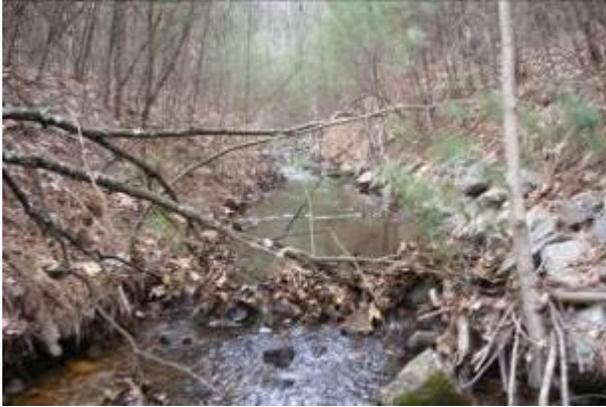
G11 More Channel Breakage

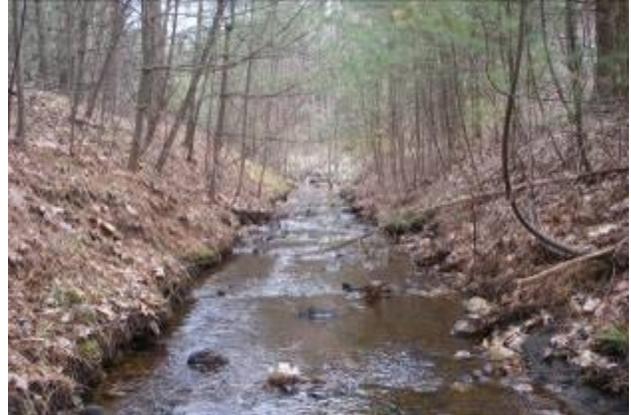
G11 Debris Overhang

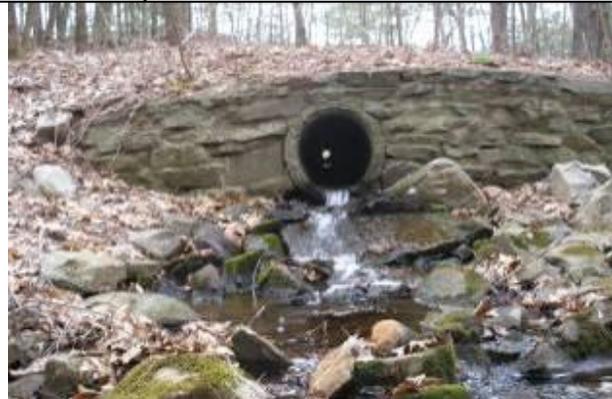
G10 3Way intersection w small trees brush block

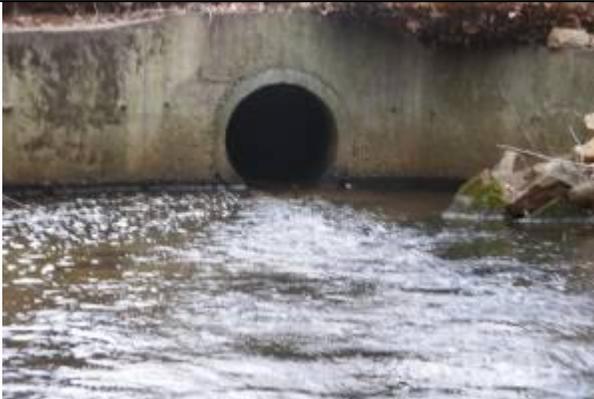
G10 24-inch Drain with Rapid Flow of Water

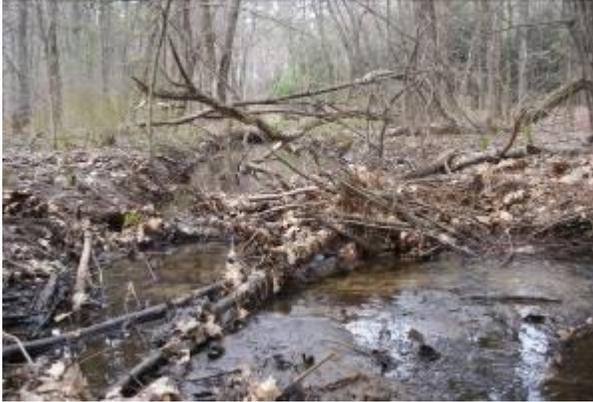
G10 Blockage

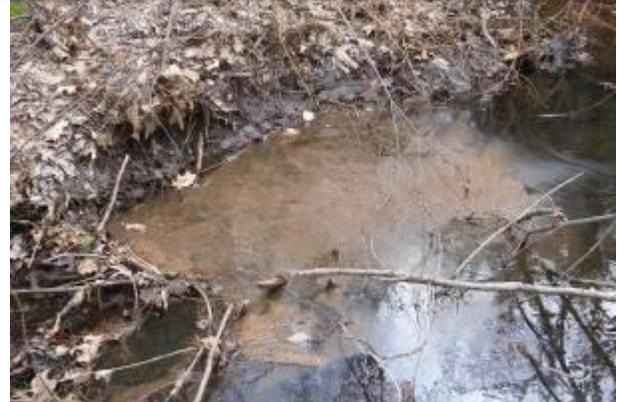
G10 Brown Muck in Water

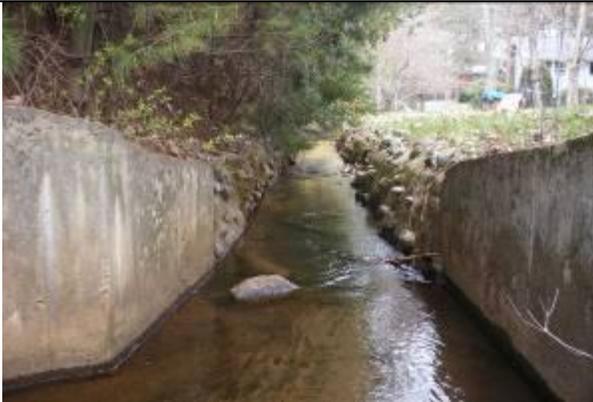
G11 Channel

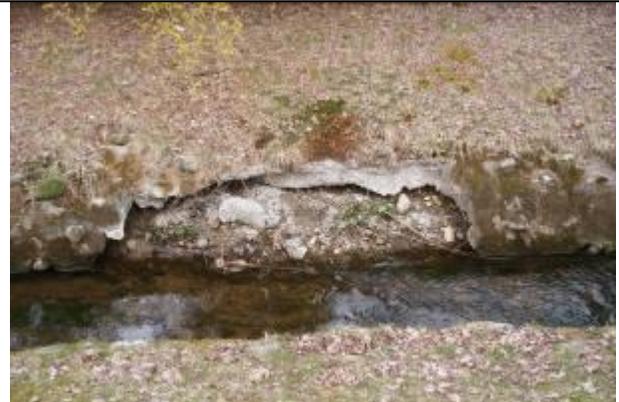
G11 More Channel Breakage

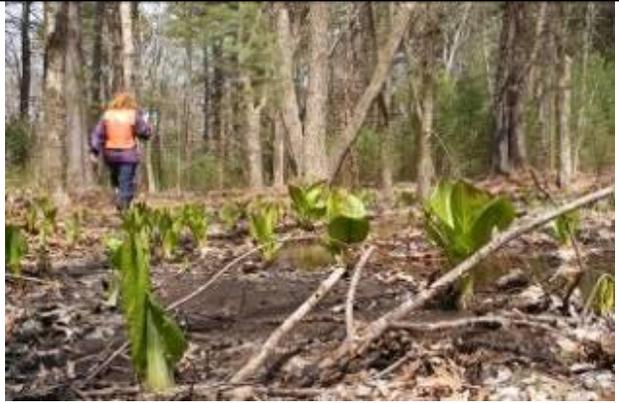
G12 Muddy, Mucky, Vegetative

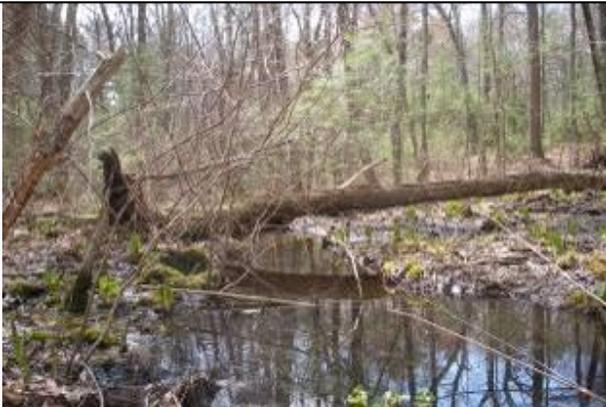
G12 Fallen Tree

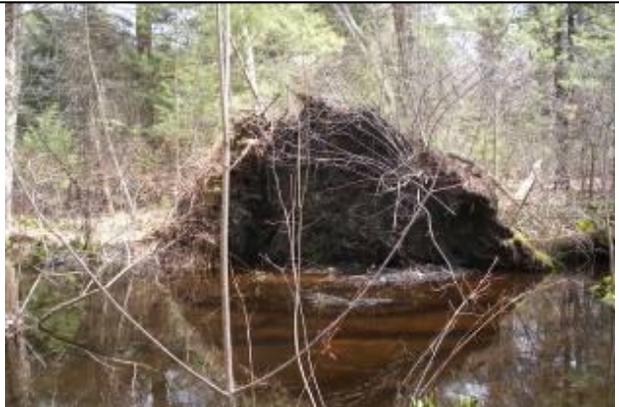
G12 Large Uprooted Fallen Tree
