# Stream Team Report

Marlborough Stream Team, December 9, 2008

## South Street and Sheep Fall Brooks Marlborough, Massachusetts

### Study Conducted November 2008

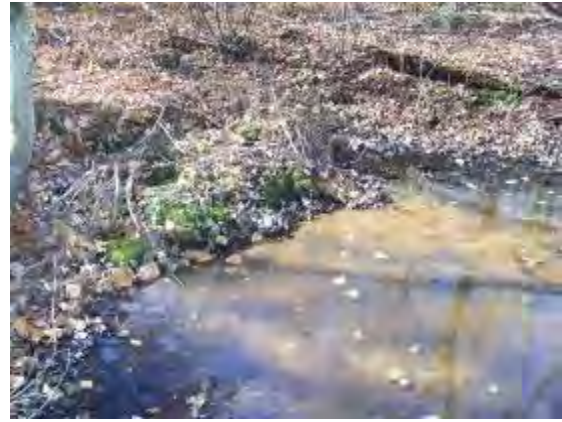
A3 This side of stone culvert is clogged

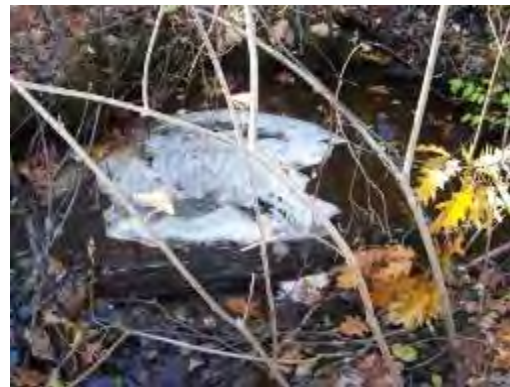
A3 Pool of foam, no odor

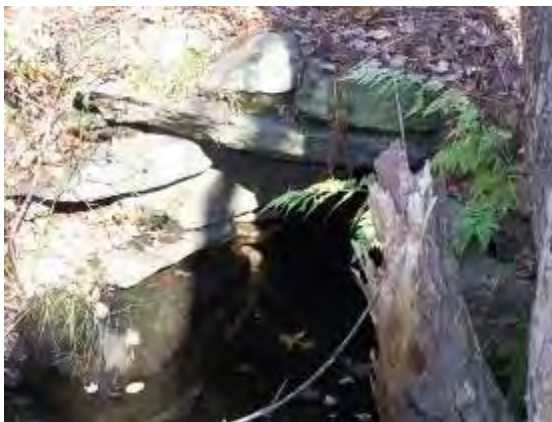
A3 Culvert

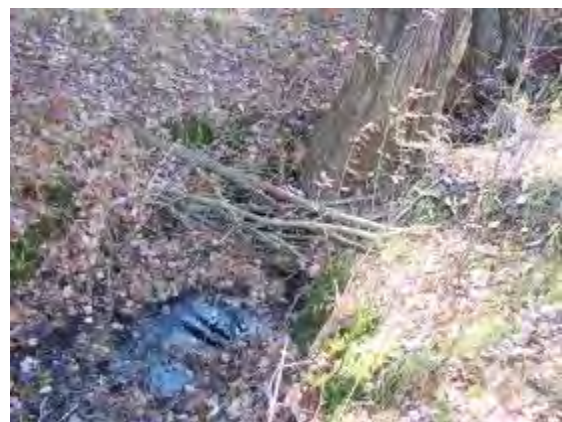
A4 Steep bank – Tree branches across

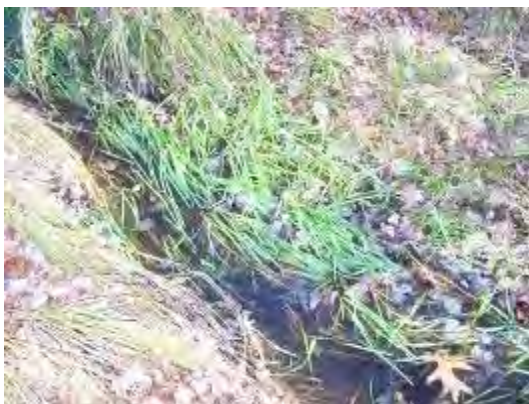
A4 Stream diminishes

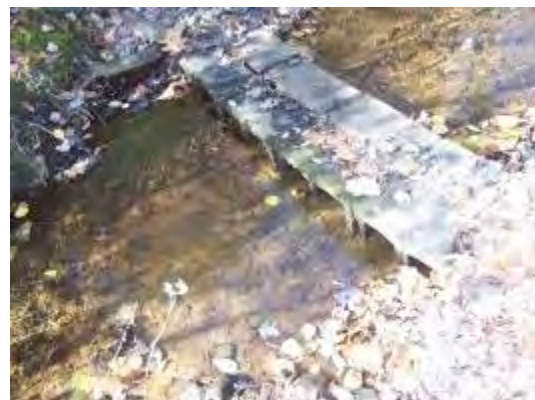
B3 Concrete cinder blocks across

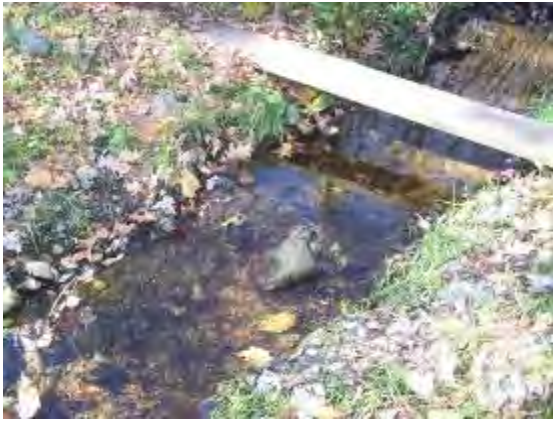
B4 Plank across

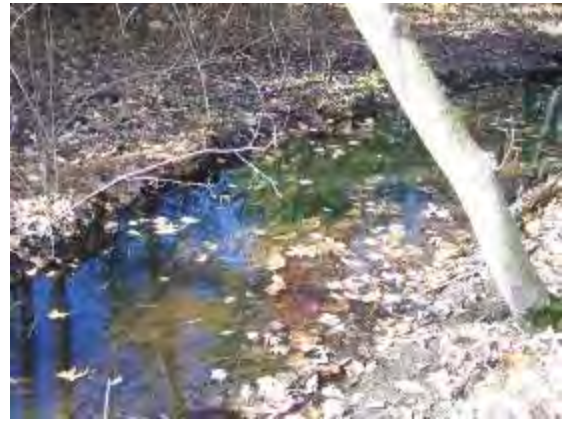
B4 Stagnant water

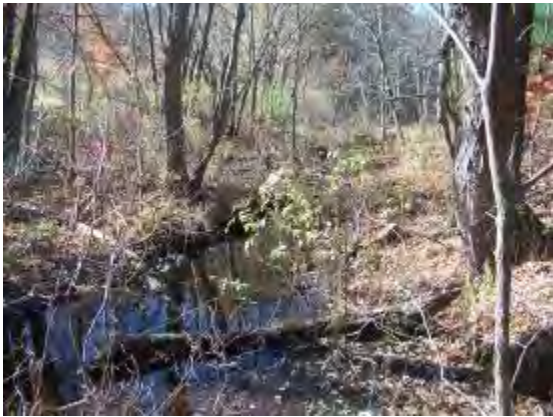
B5 Area, log across

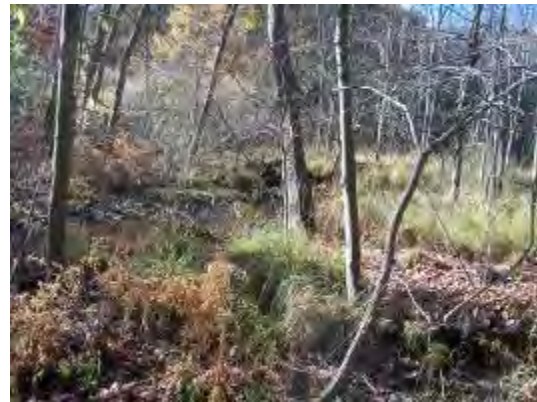
B5 Varley Road area - swampy

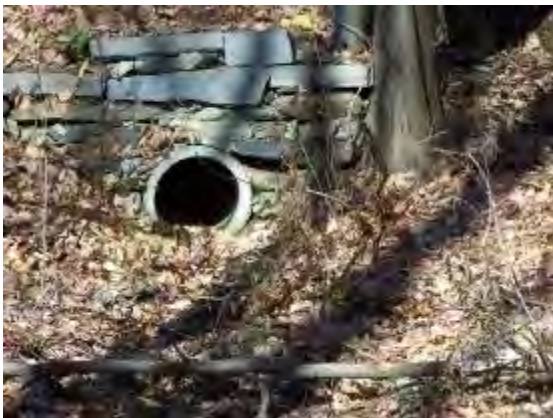
C1 McDonough Rd area – muddy

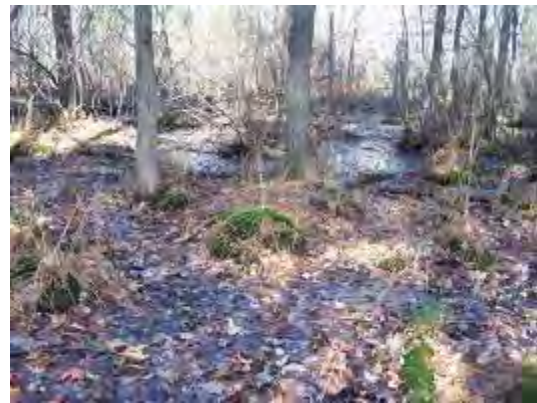
C3 Mossy - swampy

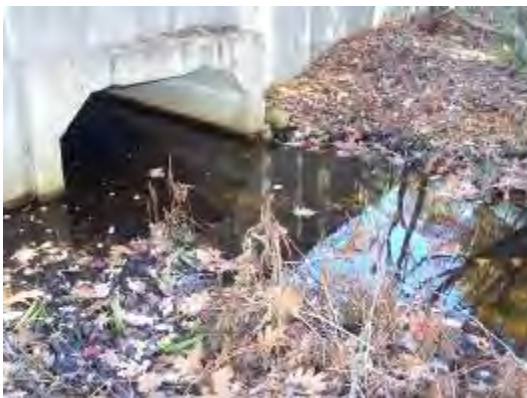
Matheson Boucher area culvert

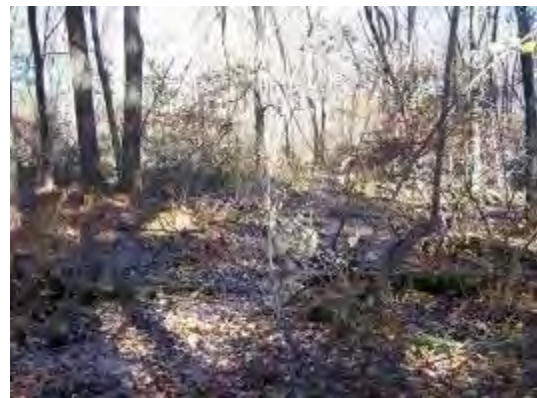
C3 Swampy area

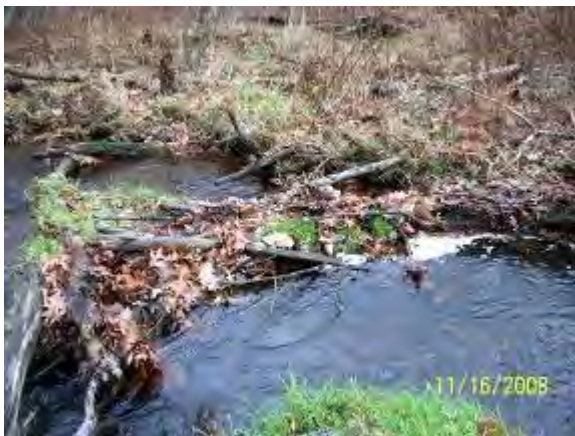
White foam by wood debris

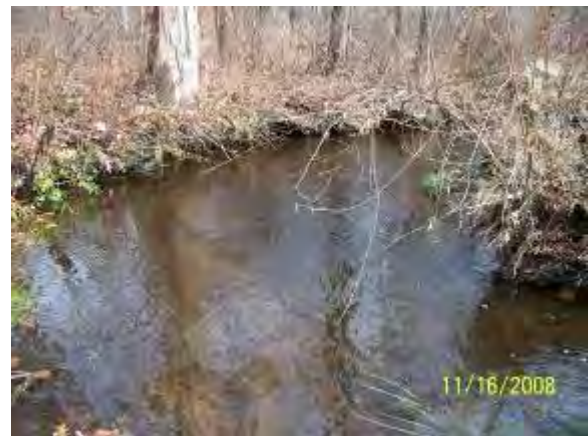
A07 Behind Assabet Valley, undercut banks

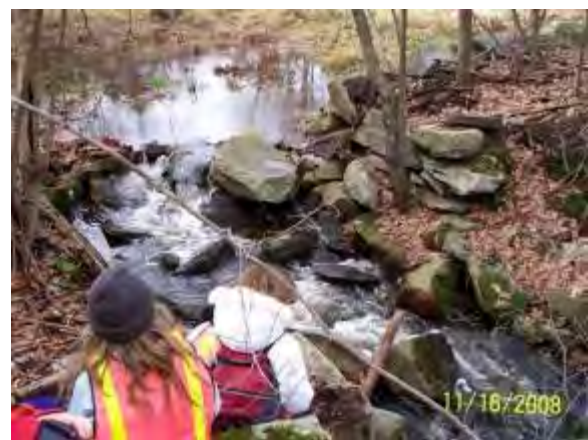
A06 Little water fall

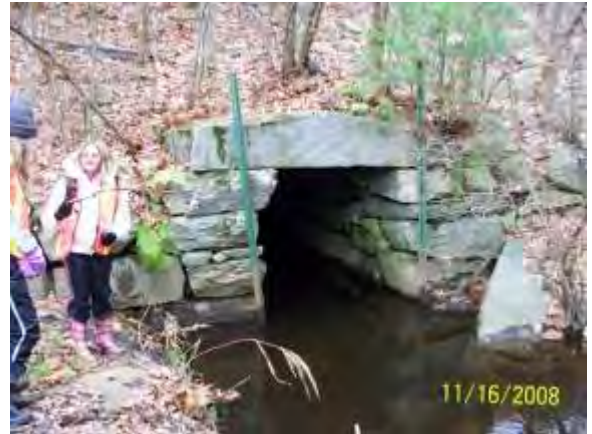
We saw bittersweet plants on the hill by Sassville Way side. The pipe we observed at 12:30 pm. It was stone in good shape. The water was brown and murky with a stagnant odor with no signs of algae. We couldn't get close enough to take measurements due to some fencing and raised pipe (see picture). (We learned that this is a pipe installed to deter beavers from building a dam in the culvert).

A06 Stone pipe in good condition

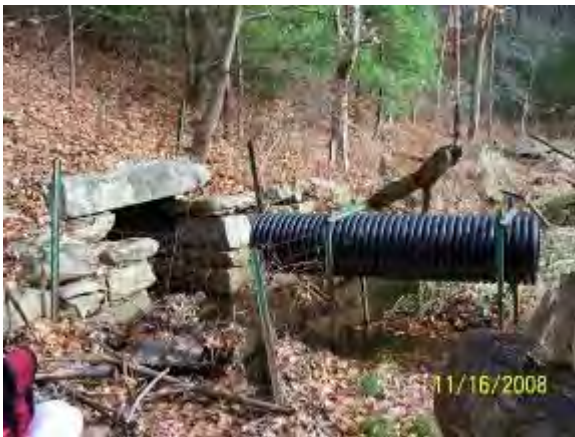
Beaver decoy behind Moose

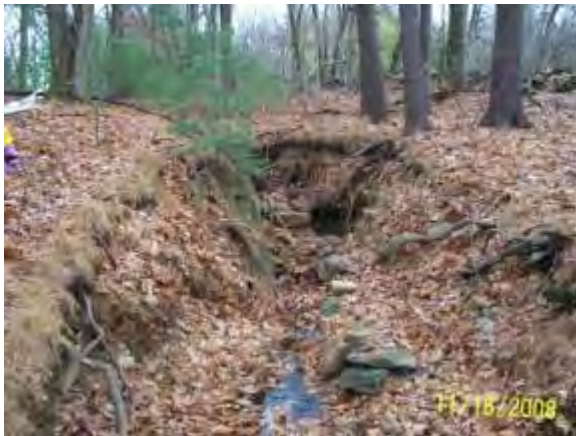
strong sulfurous odor, boulders, exposed roots, organic debris, steep grade, small waterfall and a lot of erosion, the feeder stream was 3 to 6 inches deep and babbling. There's a stone wall on the right bank. We took a water sample at a point with white foam. Roots were evident, the stream partially blocked by pine needles, leaves, debris and had a strong rotten egg like odor. The area at the top is a pool that was still and stagnant with a strong rotten egg like odor. No evidence of life. We picked up a marked trail back to the main stream and found a furry cabbage like plant on the trail (see picture). In back of the houses next to the Moose, there was a good flow. The stream was meandering with a gravel and sand bottom. The water was clear, no odor, with some debris. There are good banks with some undercut another sides with brush and wooded on both sides.

A06 Heavy erosion

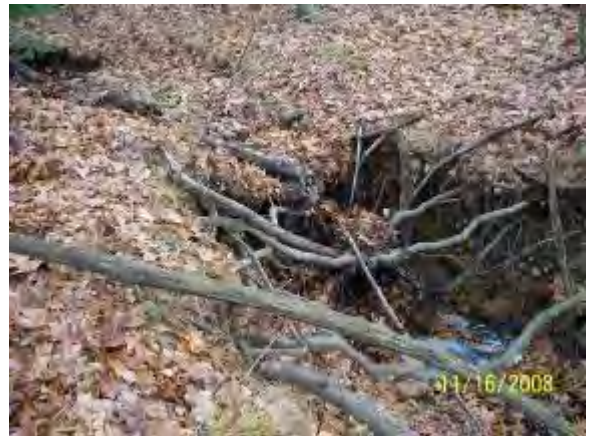
Close up, with white foam

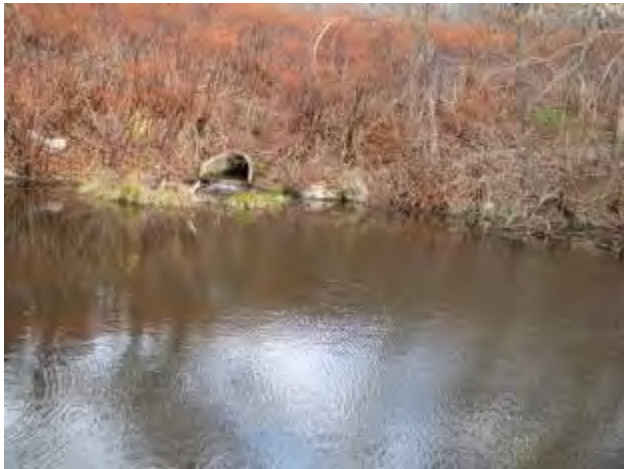
D9 Retention Pond

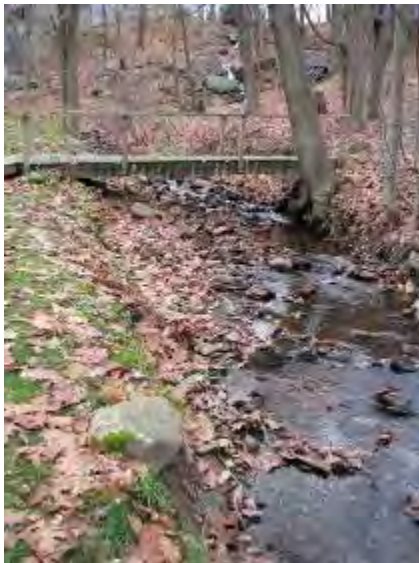
D8 near the falls/bridge at 89 Ash Street

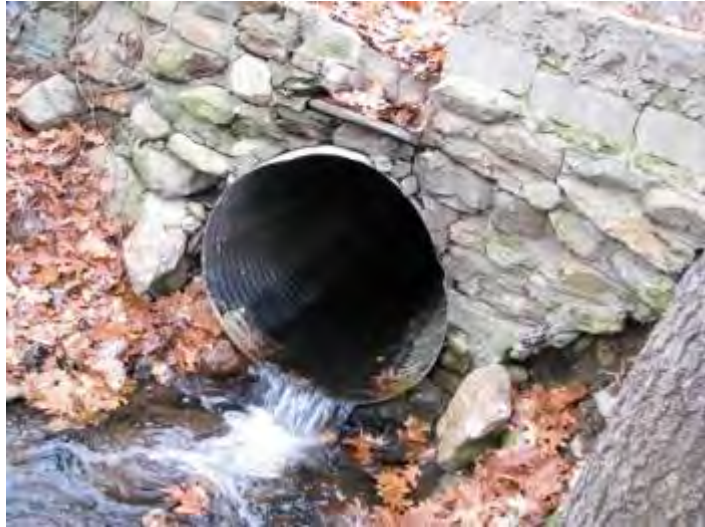
Culvert near Russell Street in either F9 or E9

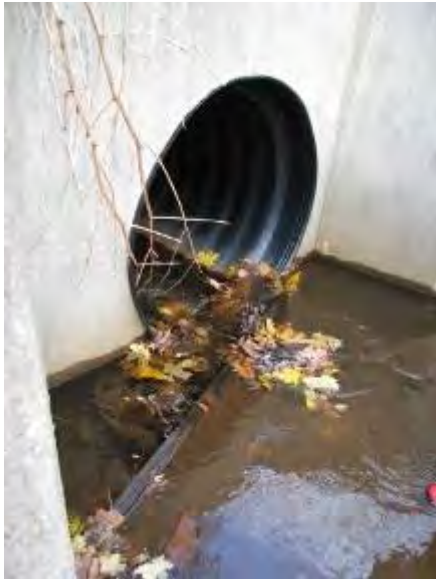
E9 culvert between Ash Street & Russell Street

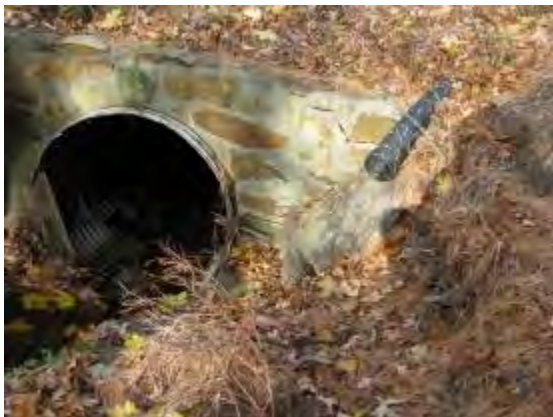
Drainage pipe from 84 Ash Street into the stream

<b>PRIORITIES</b>	Educating abutters about stream and watershed care Preventing road run off from emptying directly into stream
-------------------	--

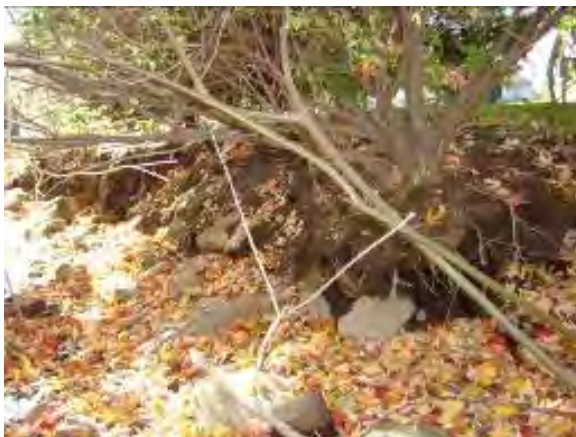
*This photo is 100 feet from the start behind two homes on Daley Circle.*

The bankings were approx. 2 - 3 ft in depth. This stretch was located directly behind two residences located on Daley Circle which is connected to Clover Hill St. A resident told us the brook would be 2 - 3 ft. higher in the Spring. We discovered pipe openings leading from each property to the brook. We surmised they were coming from downspouts on the homes.

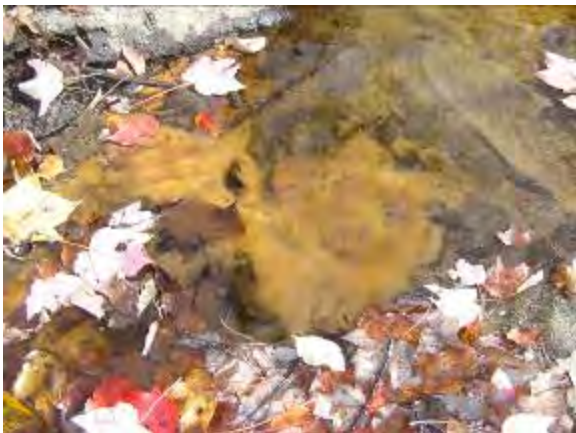
Shortly before the 1/2 mile point of our walk, the brook appeared to end (top center of photo on right), however this was due to thick over growth covering it. The brook also narrowed considerably and turned right at a sharp 45 degree angle. Here the water also became deeper

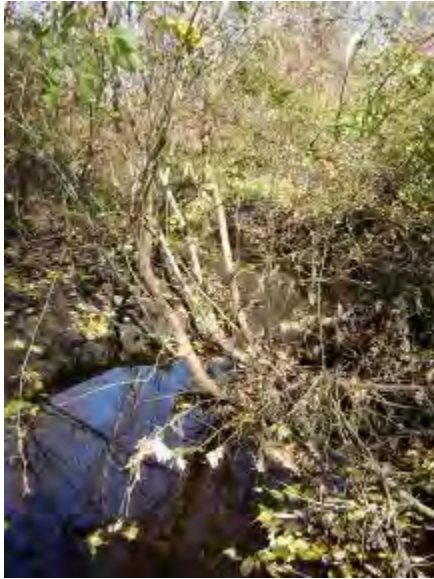
c.350 ft. further down the brook we came to a double culvert (see photo on right). Each pipe measured 2 ft diameter. One of the pipes was obviously angled downward more than the other, as we discovered when we looked at the other side. (see next photo )

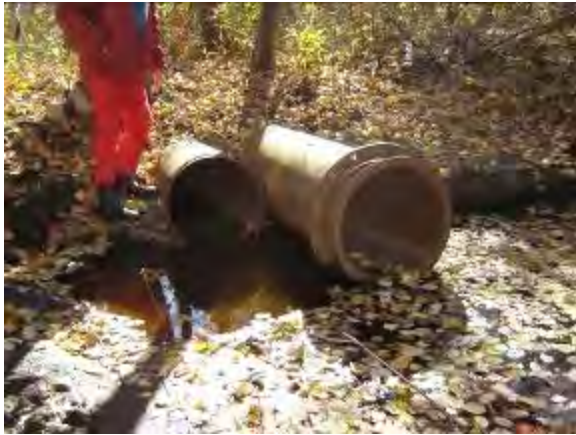
After wading through this next section of brook, we had to get on the banking as a pool had formed just before the next culverts we came to (photo below). The pool was at least 2 ft. in depth, but exact measurement was not possible. The diameter of the culverts was 2 ft.

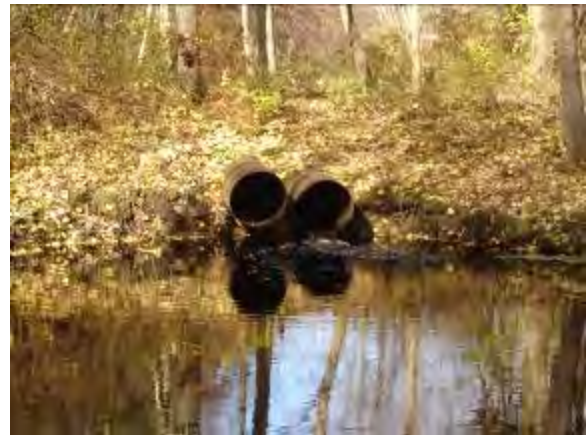
This photo (below) shows the two culverts in the photo above exiting the land bridge. Again a pool had formed which was too deep to wade through. Just to the right of the pool we discovered a tributary flowing slowly into the brook.

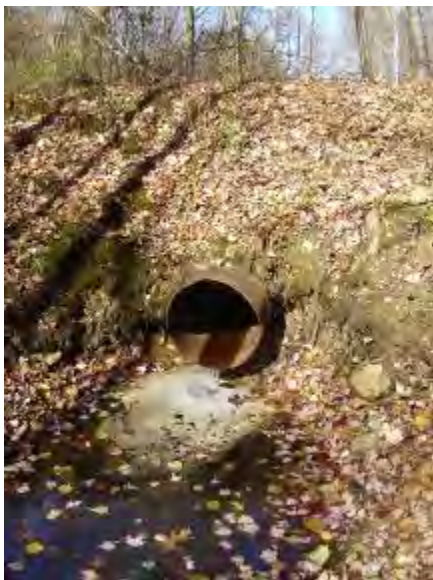
We followed the tributary for about 200 ft. and came to another land bridge with a culvert planted through it. The photo (left) shows the water flow exiting it. A brownish foam was created as the water, which appeared clear, fell 6 inches from the pipe, which was 2 ft. in diameter.

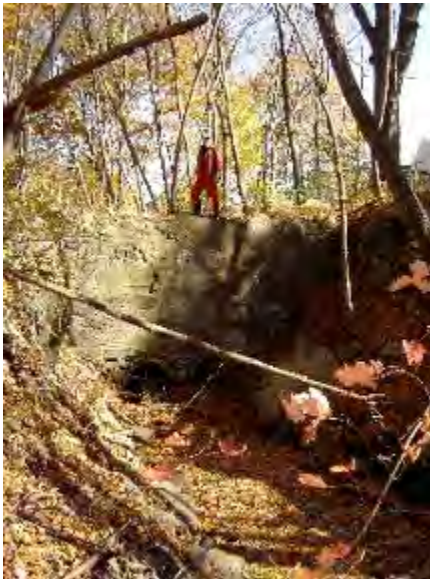
The first one we came to was curious! It appeared from this view (left) that it had been there for awhile. The stone looked quite weathered. The pipes were 4 feet in diameter and brook water flowed through them, although branches and leaves had piled up in front of each pipe. The brook had also narrowed to about 2 - 3 ft wide now. The roof of a house on Desimone Drive can be seen in the upper right corner of the photo.

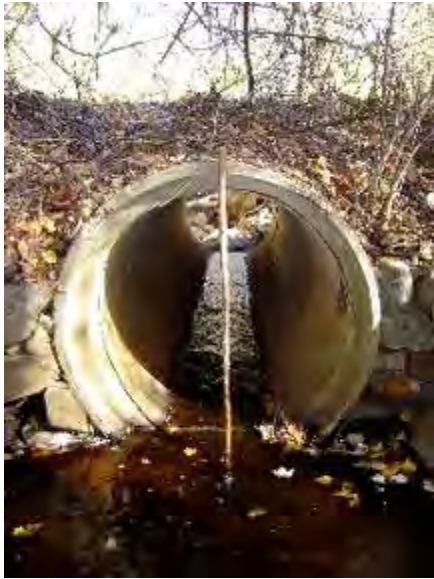
This photo (left) shows the brook entering the culvert beneath the 2nd unmarked land bridge we discovered. The water depth of the brook was about 1 ft. and the pipe diameter was 5 ft, which enabled me to actually walk through it without much difficulty, although slightly hunched over.

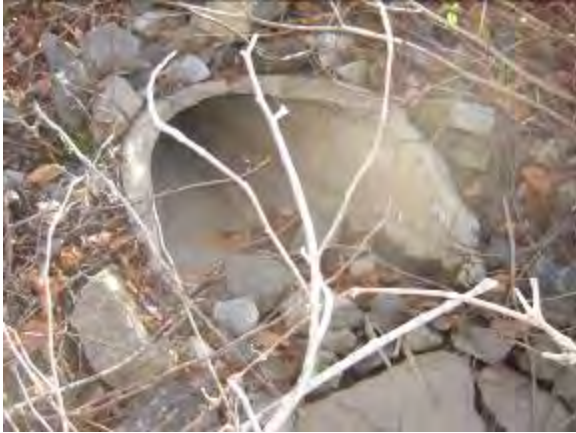
Trying to view the brook while walking along one perimeter side of the CMS, Inc. sand / gravel company, we discovered another culvert on the property line. The diameter measured 8 inches on one end, while the other end (photo left) flared out to a width of 37 inches. Although quite dry, it emptied on to the top of an embankment which sloped down toward the brook.

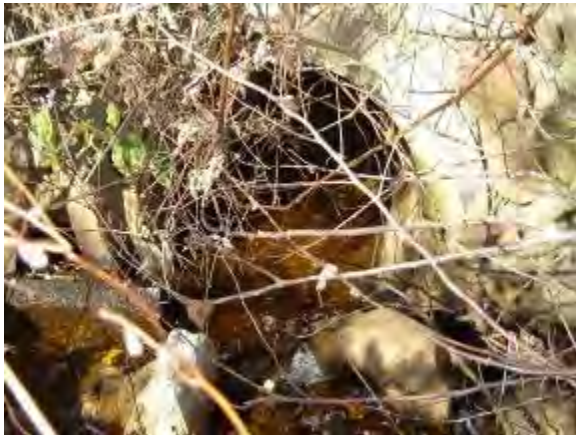
This culvert (photo left) flows beneath South St. and approximately 300 feet from the intersection of Rte 85. The brook was about 1 - 2 ft. wide at this point and was reached by sliding down a steep embankment. The diameter of the pipe was 28 inches.

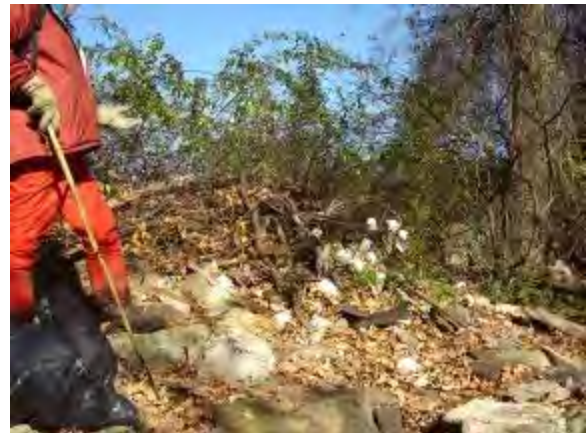
**EPILOGUE :** It was an interesting and intriguing day - all around. While on our walk we also completely filled one trash bag with assorted containers, wrappers, and miscellaneous items. The photo (right) was taken behind Desimone Drive where there was a pile of debris, including over 50 coffee cups (our estimate). In the same area we also found a rusted out auto and two discarded refrigerators. We hope this report has given some justice to our efforts on this day.

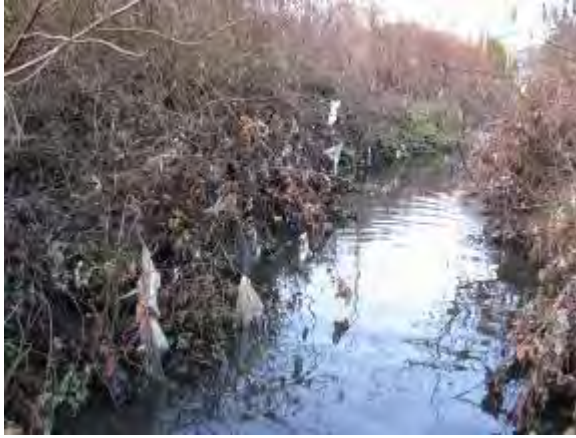
Debris hanging on vegetation gets caught there after North Branch of South Street Brook rises, showing recent high flood stage. Flooding, due to storm water runoff, deposits refuse in **A-11** behind 91-95 Neil Street area.

1) Address rapid flooding of private property adjacent to the drain pipe openings, recommend extension of piping in **A-11** downstream to DPW garage property. Because the swift, powerful current is capable of dragging in nearby objects, it is a safety issue.

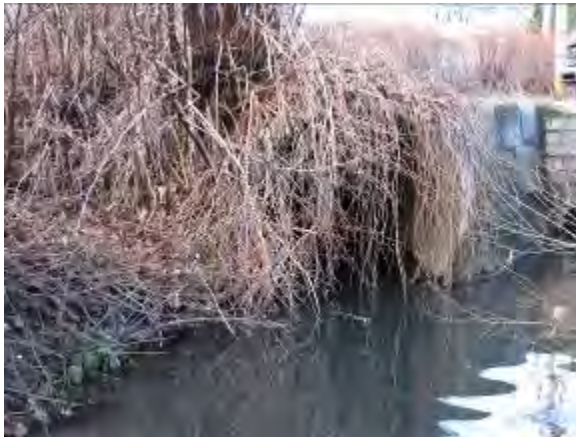
At the headwaters of the North Branch of South Street Brook in **A-11** dense vegetative stalks overhang 5' round diameter pipe at center of photograph. A smaller drain pipe is at far right. Oil slick is in foreground at right.

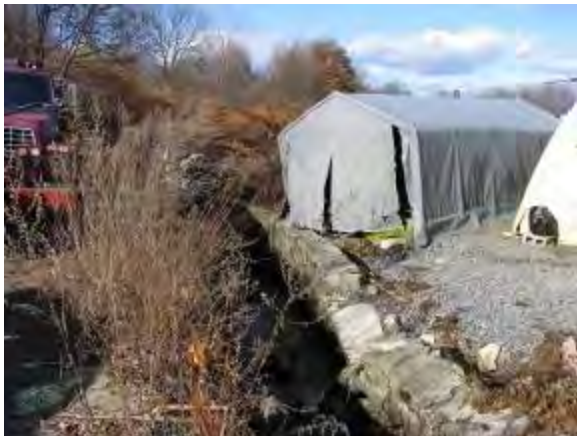
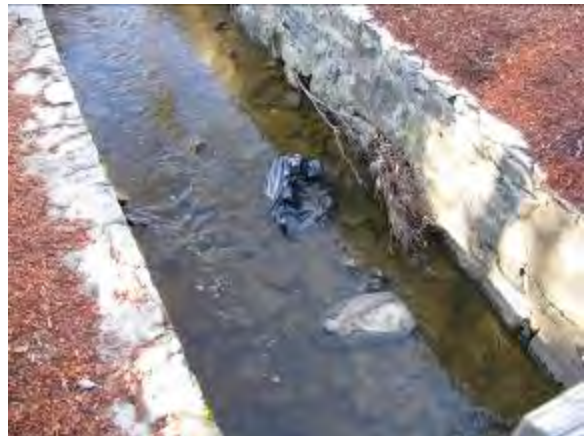
There were many raccoon and deer tracks in sand at the water's edge in **C-12**.

In **C-12** much vegetation grows thickly along South Street Brook, Northern Branch, Marlborough.

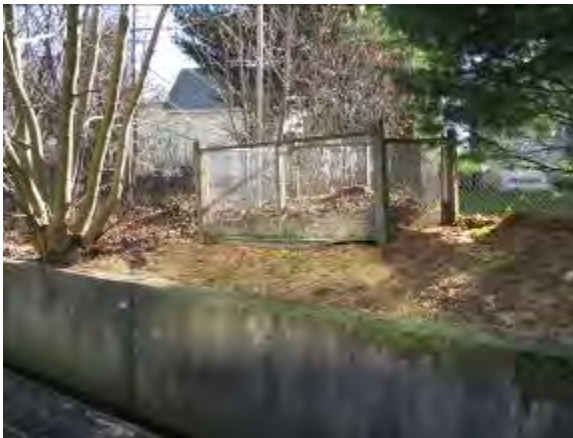
This pipe is connected to a long black rubber hose leading from a yard at 354 Maple Street. It is in the channelized segment of the North Branch of South Street Brook in **D-13** adjacent to the medical/professional building at 340 Maple Street.

Beside this channelized wall of the South Street Brook is a black rubber hose from a backyard behind the gray house at 354 Maple Street in **D-13**. The hose goes under and through a wooden planked fence, down a steep bank and into the Brook. In the yard is a swimming pool and a piece of construction equipment.

D13	a long black rubber hose going into Brook from 354 Maple Street (see photos)	<b>Con. Com. will investigate in spring 2009</b>	
D13	Composting near Brook (see photo)	<b>Con. Com. will send letter to owner to educate and suggest alternative location.</b>	
D14	A cement channel wall segment is leaning, leaving gaps (see photo)	<b>DPW and DCR will be notified of this condition.</b>	
C13-D13	Clean up pond behind Monty's.	<b>DCR will be notified. Area will be put on cleanup list for Clean Sweep (If permission granted by DCR).</b>	
D14	Remove blockage in channel (trees and organic debris).	<b>DCR will be notified.</b>	
E14	Walker St. Bridge – remove	<b>DCR and DPW will be</b>

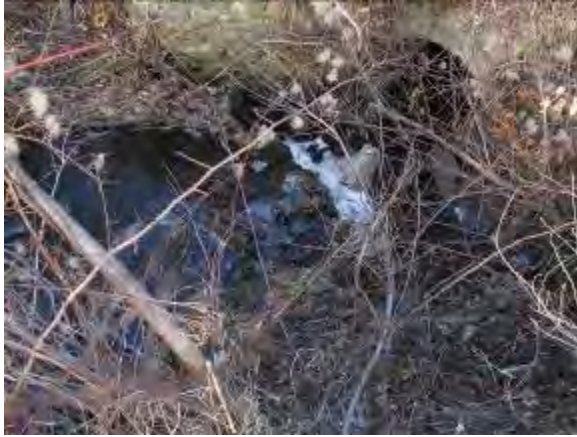
Culvert south of South Street

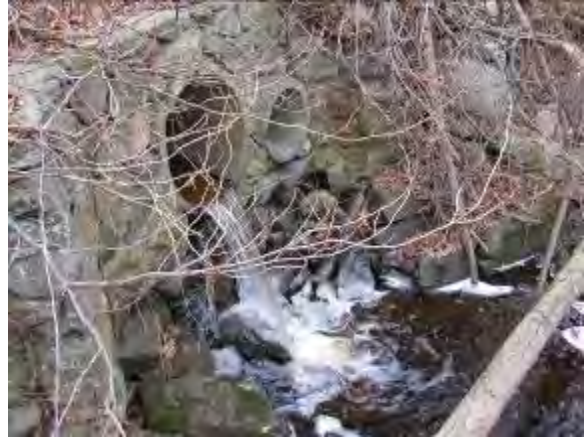
Culvert north of South Street

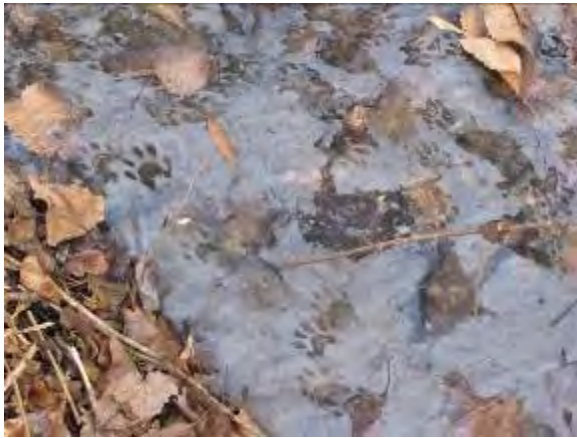
Animal tracks – Fisher?

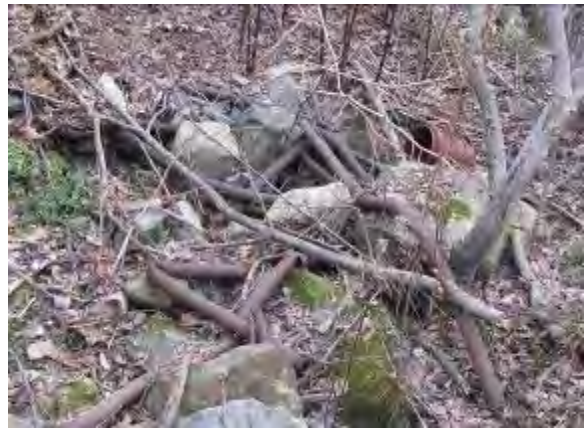
Debris – metal pipes and other trash

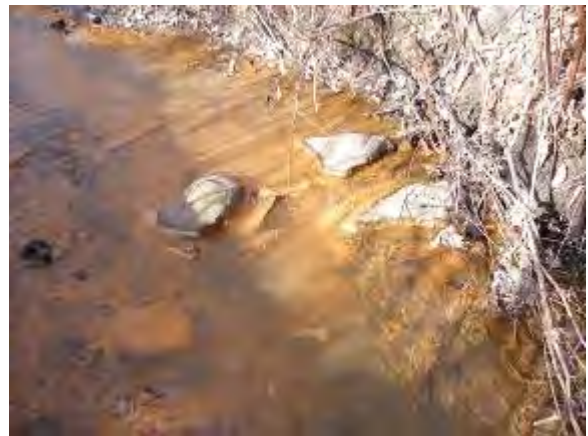
C13 Brown Colored Stream

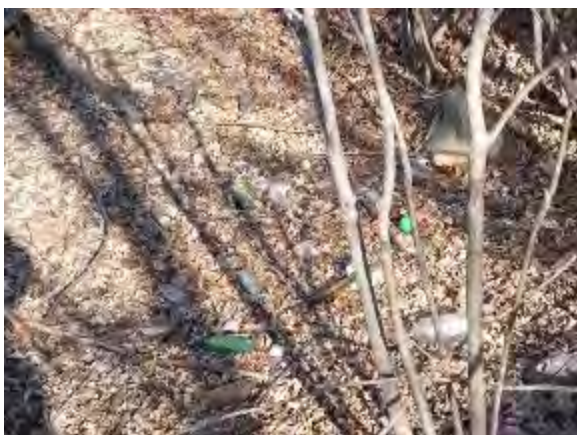
C13 Trash Around Pond

1. Great double action priority – clean up pond behind Monty’s to provide community recreation for winter (ice skating rink). It would also provide wetland for good habitat in summer.
2. Clear up fallen debris/blockages in all areas noted (D14, E14, F15) to help healthy flow of stream
3. Cover open manhole (F15) – dangerous to humans and wildlife

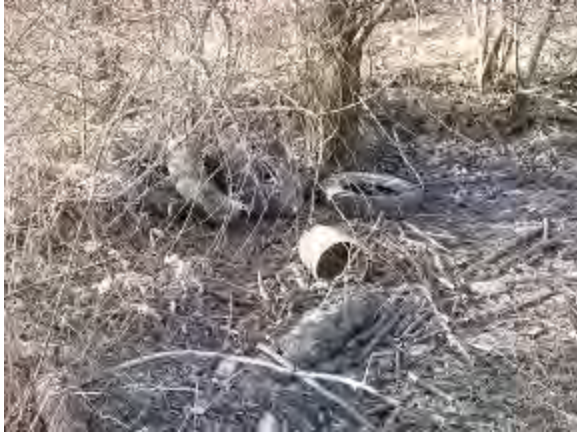
C13 Trash around pond

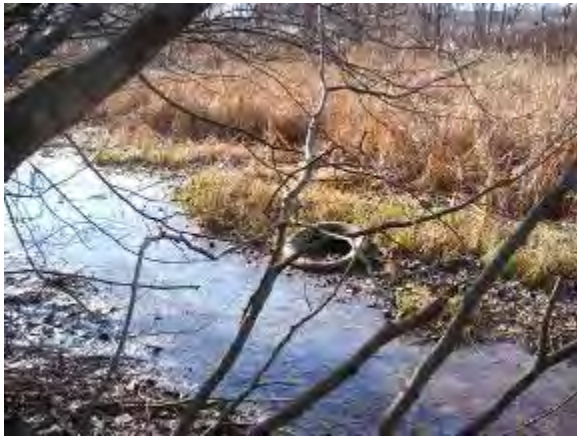
C13 Trash in Stream

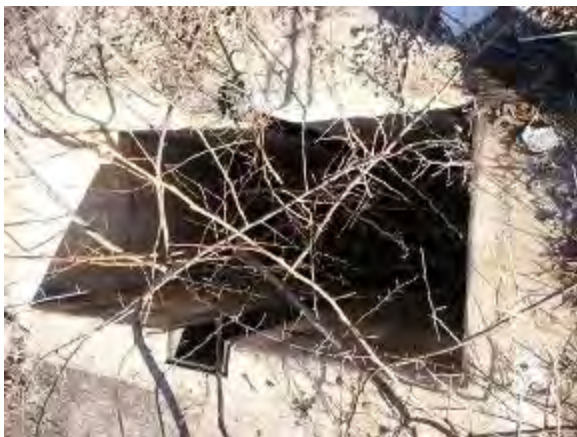
F15 Open Manhole

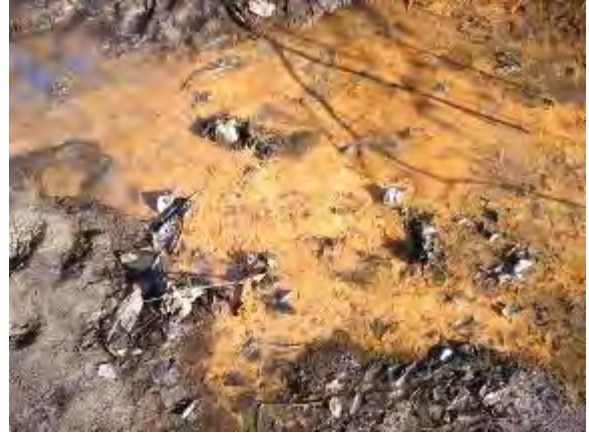
E14 Brown-Colored Pool

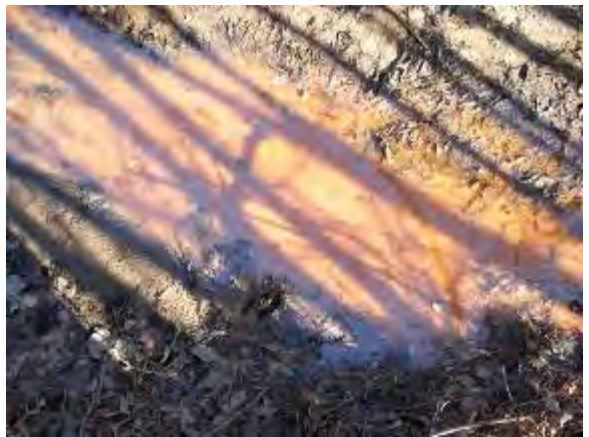
E14 Brown Colored Pool

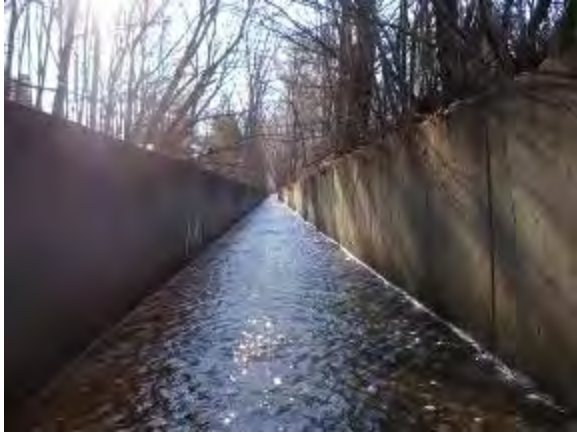
E14 Channel Flow2

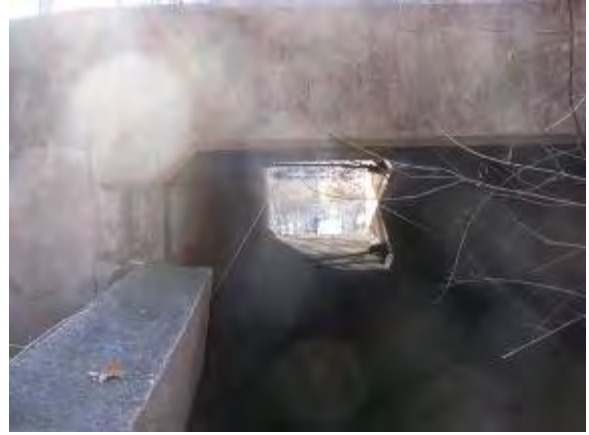
E14 Channel Flow 1

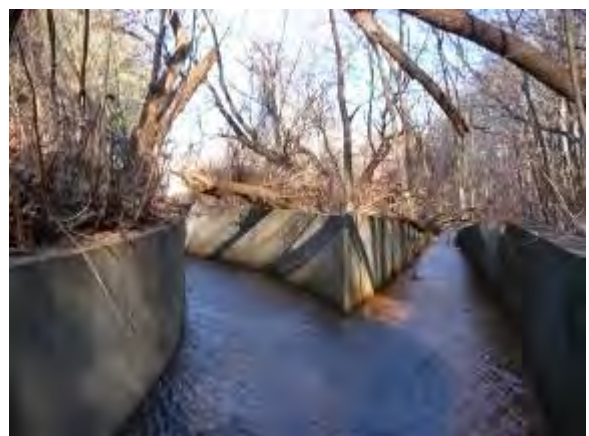
E14 Channel Walker Street Culvert Upstream

sediment accumulation both sides upstream and downstream	<b>notified of this condition and asked to remove it when possible.</b>	
F15	Check pipe right after spillway discharge, blockage	<b>DCR will be notified.</b>	
F15	Fallen branches over channel	<b>DCR will be notified.</b>	
F14	Beaver Dam – inspect	<b>DCR will be notified and will address issue if it is a problem.</b>	
F15	Open manhole to be closed for safety	<b>DCR will be notified and asked to block this off for public safety purposes.</b>

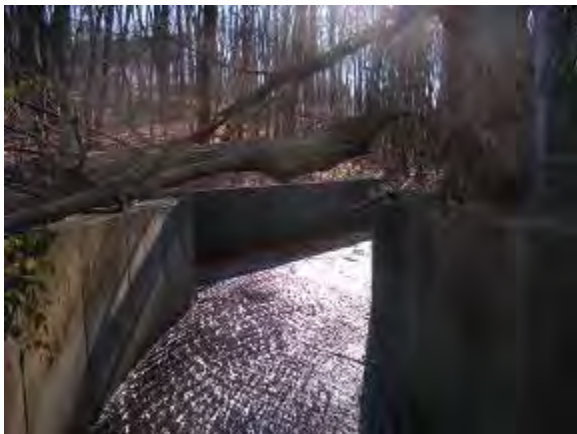
D14 Channel Merge Downstream

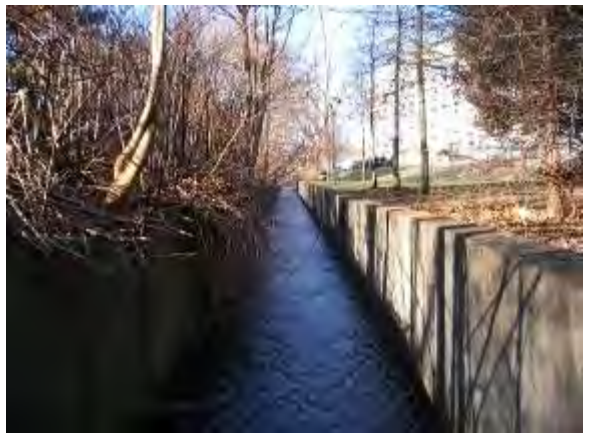
D14 Channel Merge Upstream

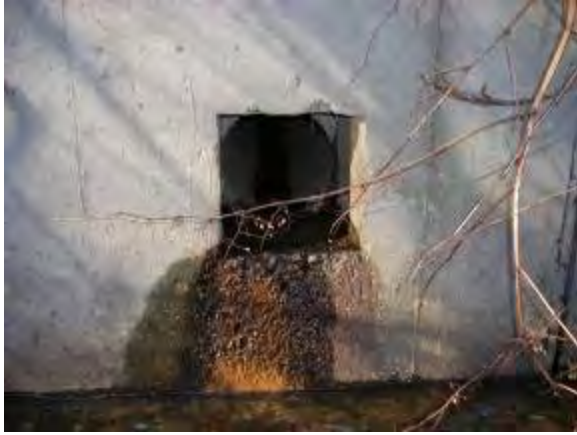
D14 Channel Flow 1

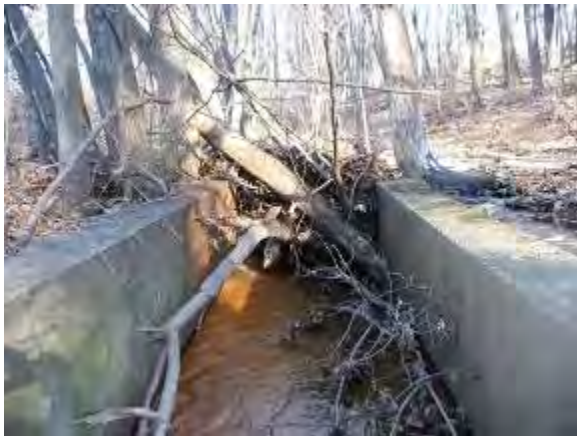
D14 Channel Wall Shift Upstream

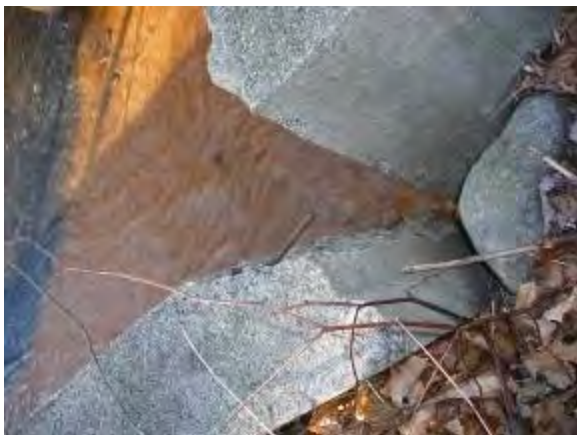
D14 Channel Blockage Drainage

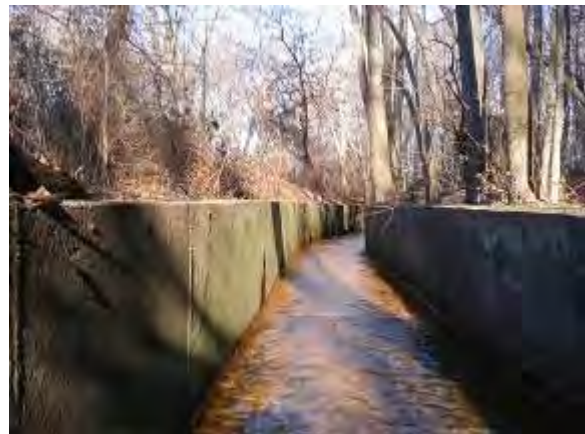
D14 Channel Wall Shift Downstream

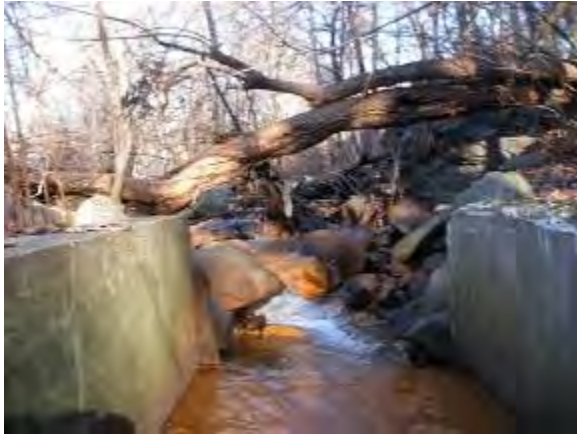
D14 Channel Flow 1

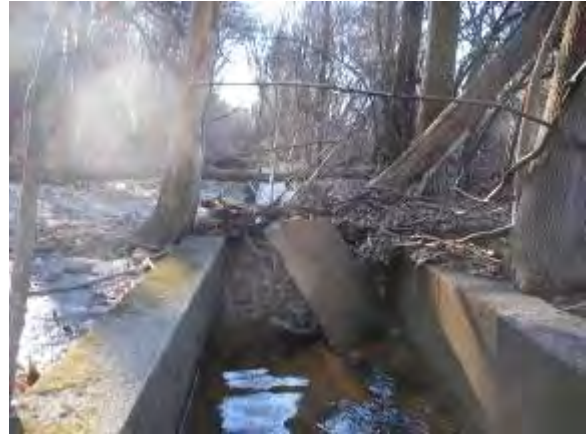
D14 Channel Start
