Stream Team Report

Various Streams Marlborough, Massachusetts

Study Conducted April 2010

Compiled by: Priscilla Ryder (with help from Jen Boudrie)

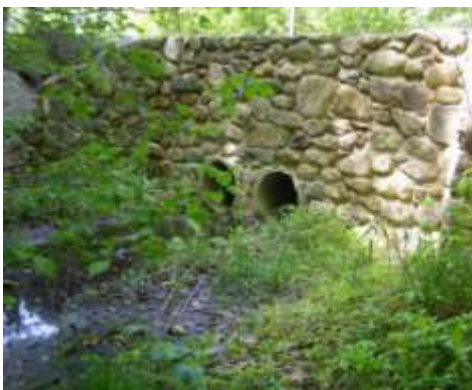
On May 11th we entered the east branch of the westerly stream below O'Leary from O'Leary Street beginning at the stone wall with a large double culvert under the road. (C05) Like the majority of culverts we encountered, this one is cement, in good shape with no obstructions.

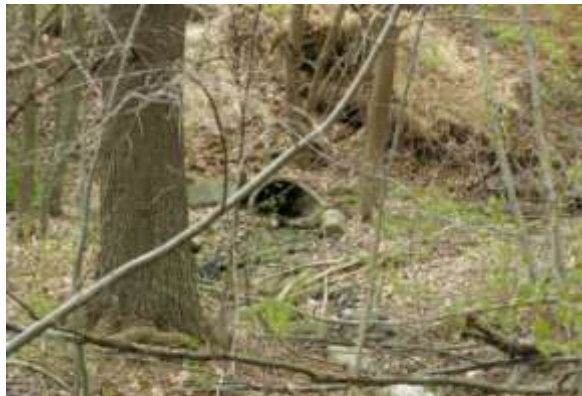
Just north of O’Leary we came across a cement retaining wall in the middle of the woods with a culvert in it – here the stream goes underground for about 30 feet and exits from a culvert into a large pool.

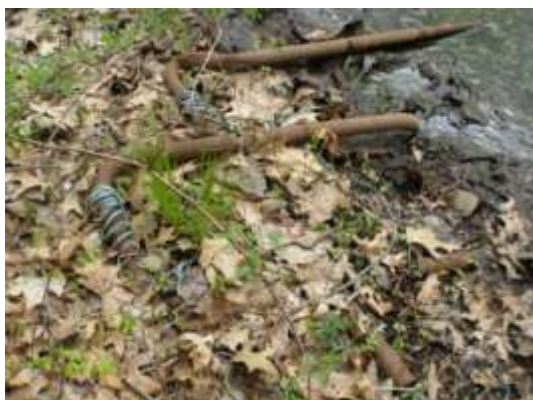
Just north of the pond in D05 we observed a few small patches of oily sheen which appear to be synthetic with no odor. We also noted a muddy area with lots of animal prints. Surrounding the pond in D05 there was quite a bit of construction waste including rusty pipes, PVC pipe and lumber.

Stream section	Problem Identified	Assigned to:	status
Stream 1			
Section: D-05	The corroded metal culvert with black hose exiting and running in streambed for a great length. . Construction waste along eastern edge of pond in D05.	Conservation Commission will investigate these pipes and determine if they are a hazard. If so efforts to have them removed will be taken.	
Section: E06	Sewer type pipe in streambed near Farm Road	Conservation Commission and DPW will investigate	
Sections:C6,C5,	Hanging culverts- most of the culverts observed in this section have hanging culverts	Conservation Commission is now aware of this, when repairs are made to these structures – this will be addressed.	
Stream 2			
Section B-2	Beaver activity at Jericho Hill pond outlet	Conservation Commission to investigate and work with DPW	DPW notified in summer 2010, clogged outlet was addressed. Ongoing monitoring needed to resolve problem.

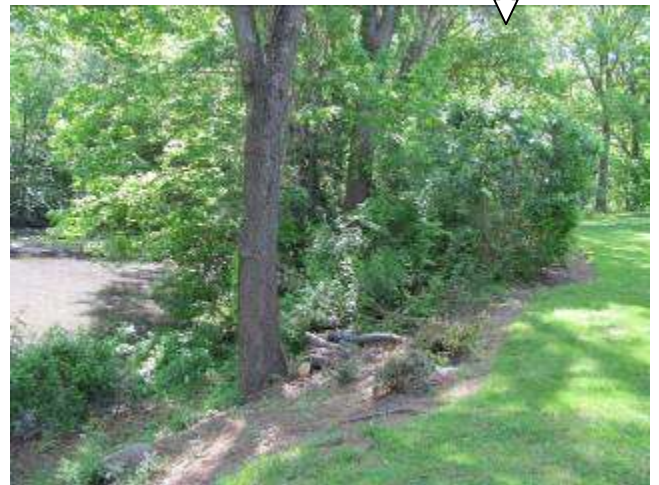
Culvert from field below sledding hill

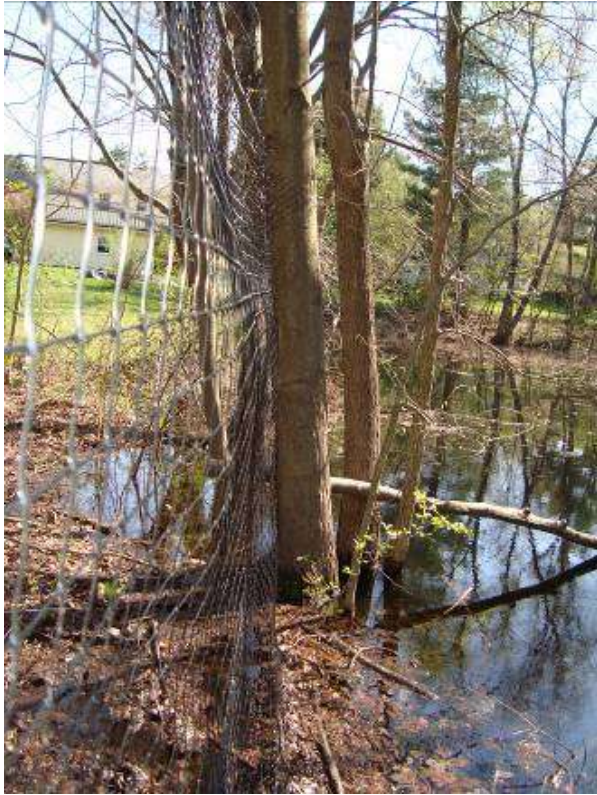
A12, B12 East Side of Hosmer Street near Causeway Street junction

What seems to be a 7ft high deer fence is erected between Hosmer Street near the red fire hydrant and the pond (photo left) in B12. The fence is about 800 feet long.

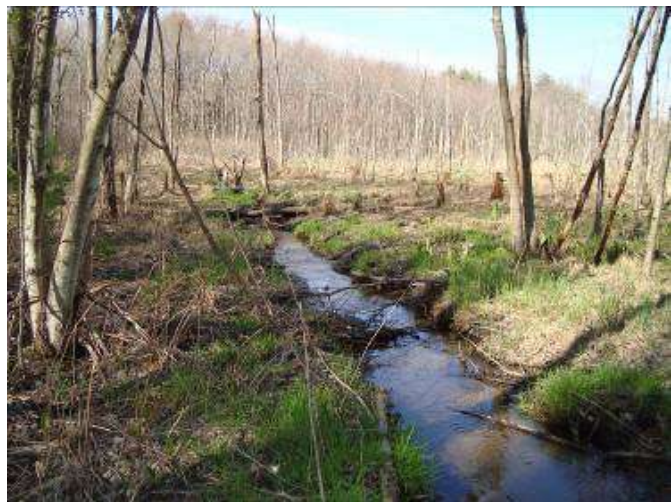
The stream water through the wetland was running clear and I saw no signs of beaver activity. (photo below)

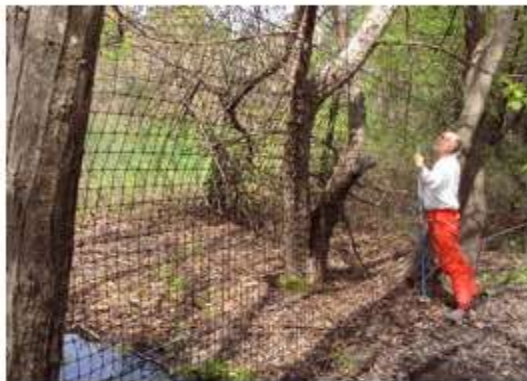
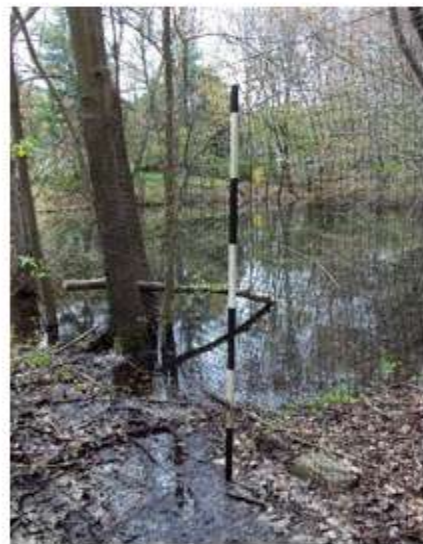
Area B12

fence surrounding property near pond

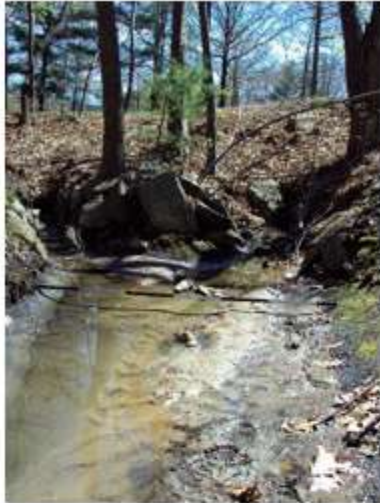
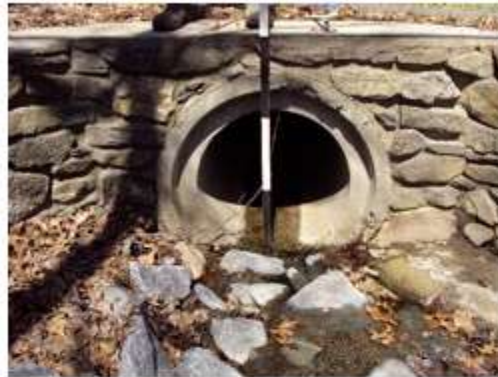
*** Tarred stream bottom ***

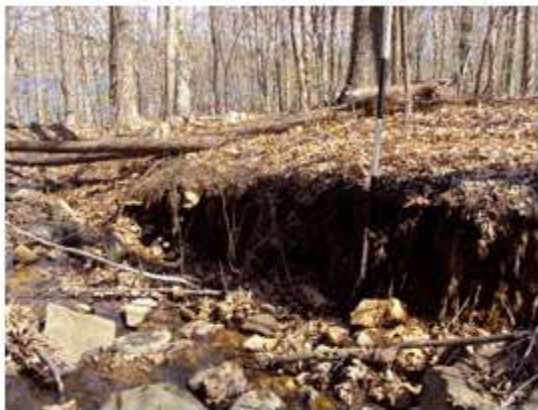
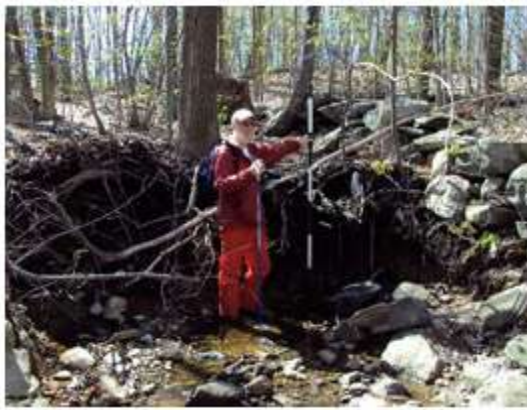
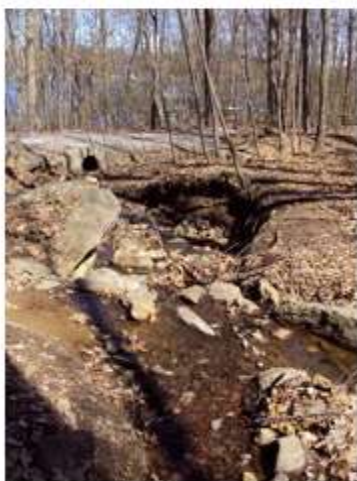
E05

.....washed out areas (due to recent heavy rainfall ????)

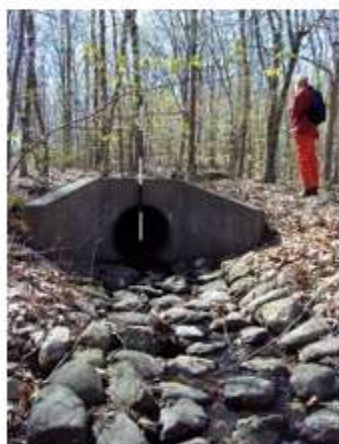
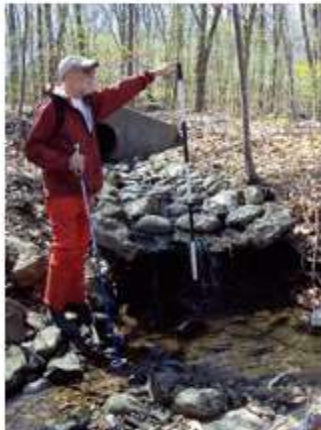
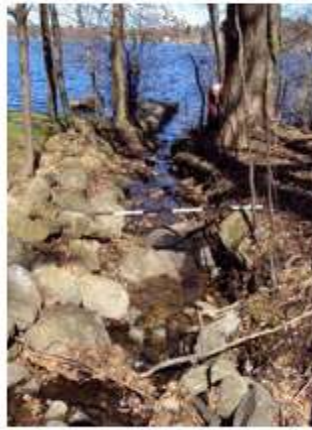
.... other side of culvert ... leading to Fort Meadow . The large stones apparently on the stream bed, were actually cemented into a large piece of concrete . *** NOTE how the base has been washed out !

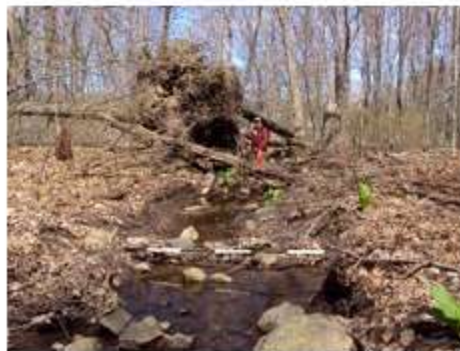
... huge uprooted tree ...

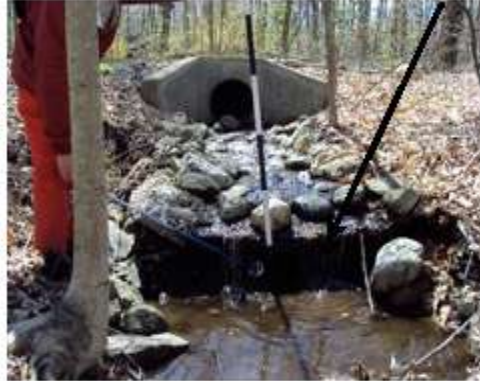
... exit side - *** NOTE large rocks cemented to concrete base and washed out stream base .

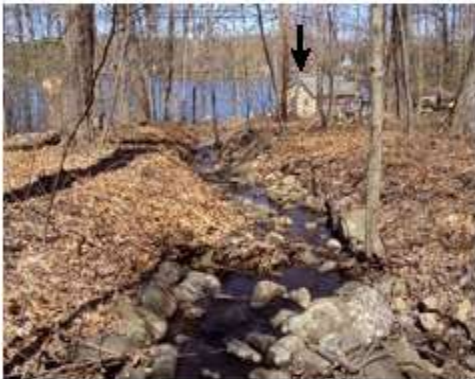
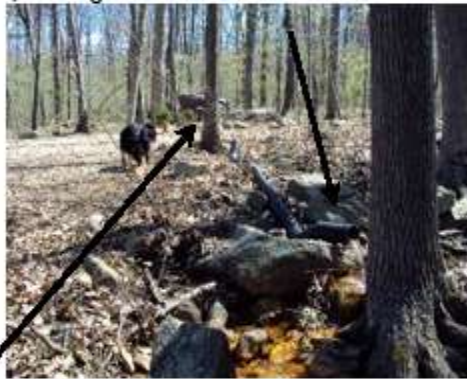
* Owner (photo left) was pumping water into stream. Stream bed became discolored, although water out of hose seemed clear ..

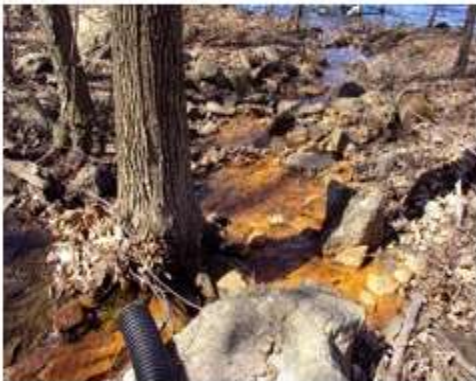
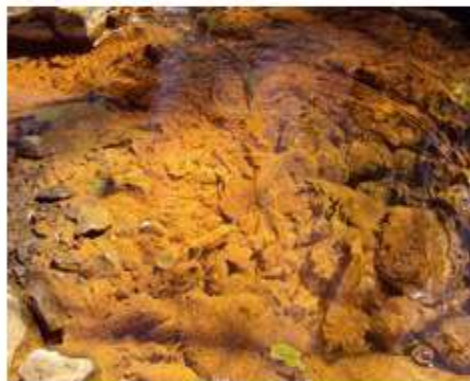
... hose was attached to a pipe coming out of the ground

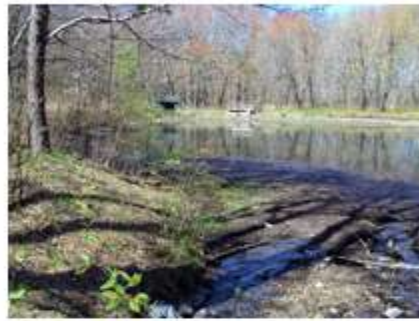
.... stream exits culvert and empties into Holt's Grove (Pond)

... water level of pond seemed about 2 ft. lower than "water stain" on concrete "dam" ... one side of concrete structure appeared washed out by earlier rainy period and remedied by sandbagging also abundant plant growth covering water's surface ... much litter as well ...

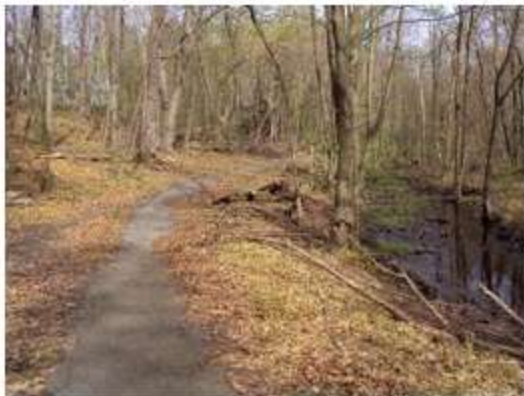
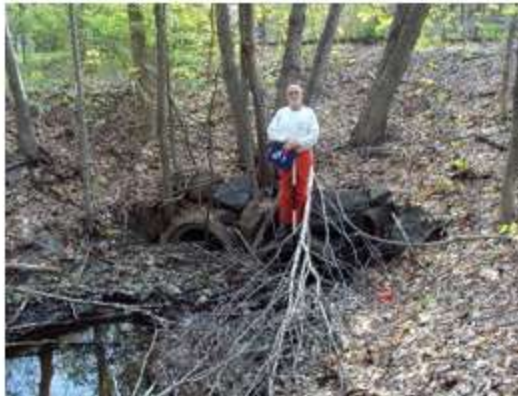
Stream follows adjacent route beside tarred path, which runs from Stevens St. (near Middle School) and eventually enters two clogged culverts on Kings Grant Road.

- clean downed trees at culvert opening & clogged culverts on Kings Grant Road. (H06)
- check out cracked culvert encasement at end of Ridge Road (E08)

Section: H-06	Clear downed trees at culvert opening and clogged culverts at Kings Grant Rd.	Conservation Commission will work with DPW to address	
Section: E-08	Check out cracked culvert encasement at end of Ridge Road	Conservation Commission to work with DPW to investigate	
Stream 4			
All sections with trails	ATV activity through some of the trails near the brooks	Conservation Commission will investigate	Commission contacted state environmental police in summer 2010, investigation and enforcement is underway.

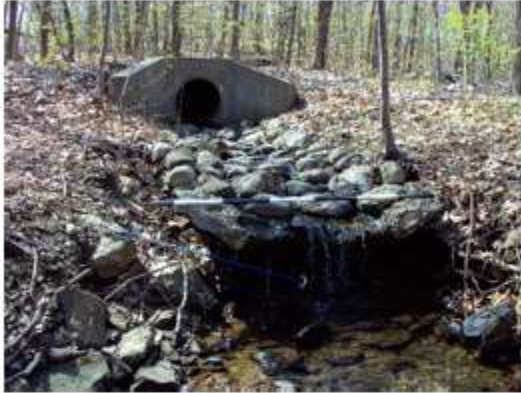
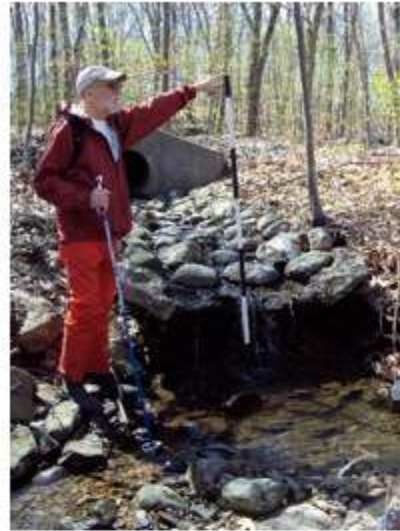
Red Spring Road (Map - E05 & E06)

stones on concrete bed end of 20 ft. long bed
has been washed out

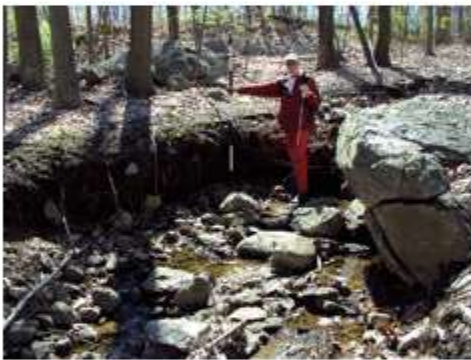
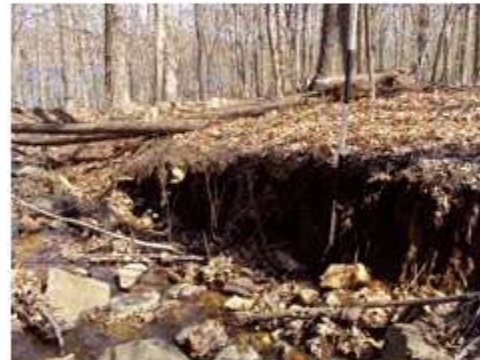
same area (below) washed out stretch of stream just before Red Spring Road

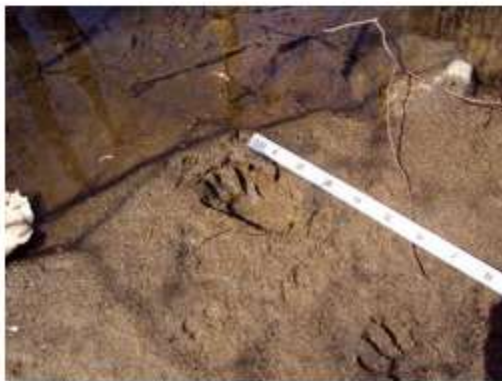
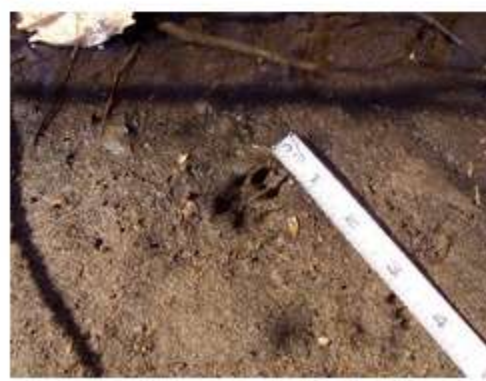
same area (below) ... animal prints

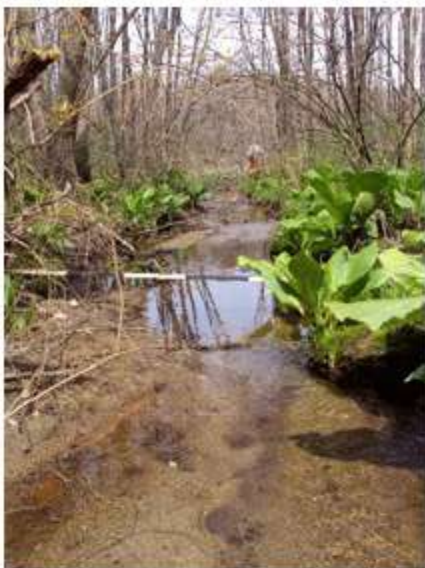
Area A12

These are final pictures the first 4 that go with A12 section (note the strange device below is a beaver deceiver to help keep beavers from over flooding an area). The algae in the bottom frames will continue to be monitored to determine what is the cause of this growth) in section H06.

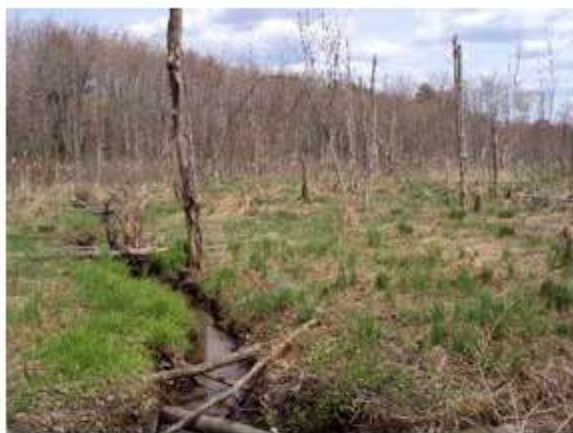
stream from pond (B12) runs into wetland

strange device and headless crow found in the wetland

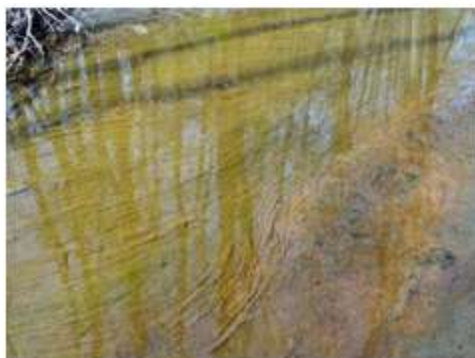
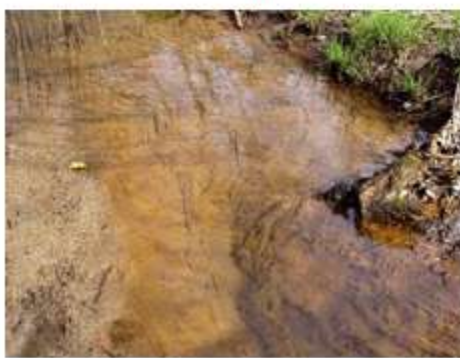
Area H06 (stream from Stevens St to Kings Grant Rd.) long stringy algae
